*Oyster Bag Sill Construction
and Monitoring at Two Sites
in Chesapeake Bay*

Oyster Bag Sill Construction and Monitoring at Two Sites in Chesapeake Bay

Virginia Institute of Marine Science

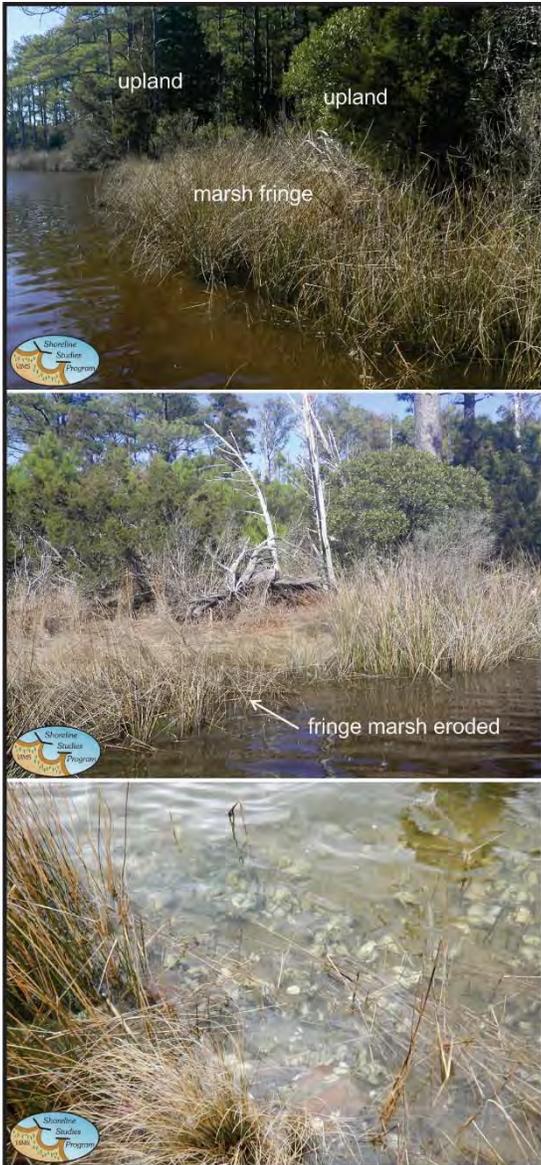
Figure 2-3. Existing conditions at Heritage Park. Top: A low upland bank is protected in some areas by a narrow fringe marsh. Middle: In other areas, the marsh fringe has completely eroded. Bottom: Oysters are prevalent in the nearshore at the site.

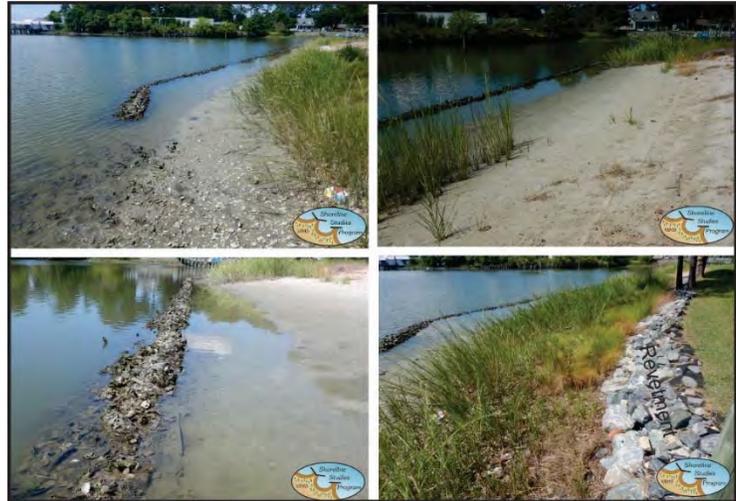
Figure 4-6. Present condition of Site 1 oyster bag sill (6 September 2018).

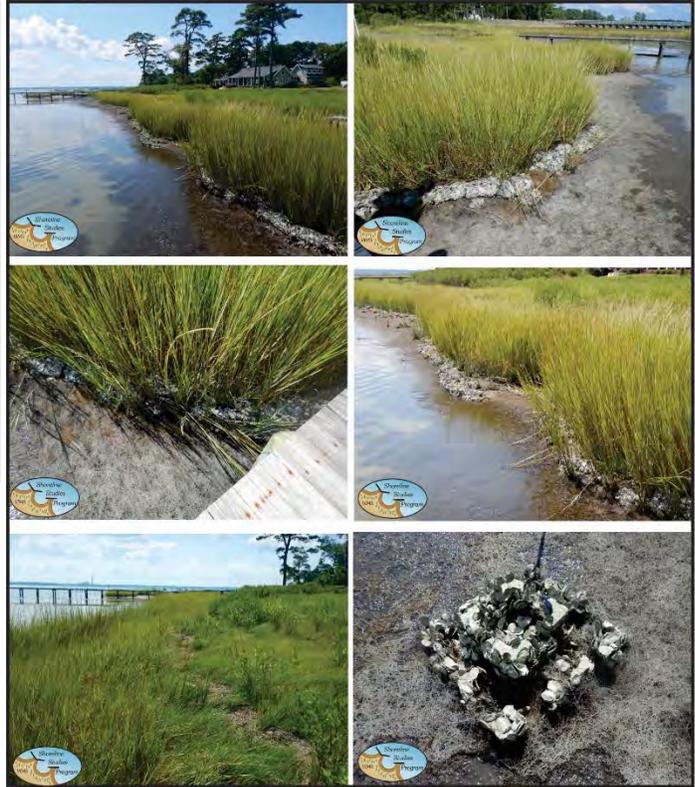
Figure 4-12. Site 2 sill in September 2018.

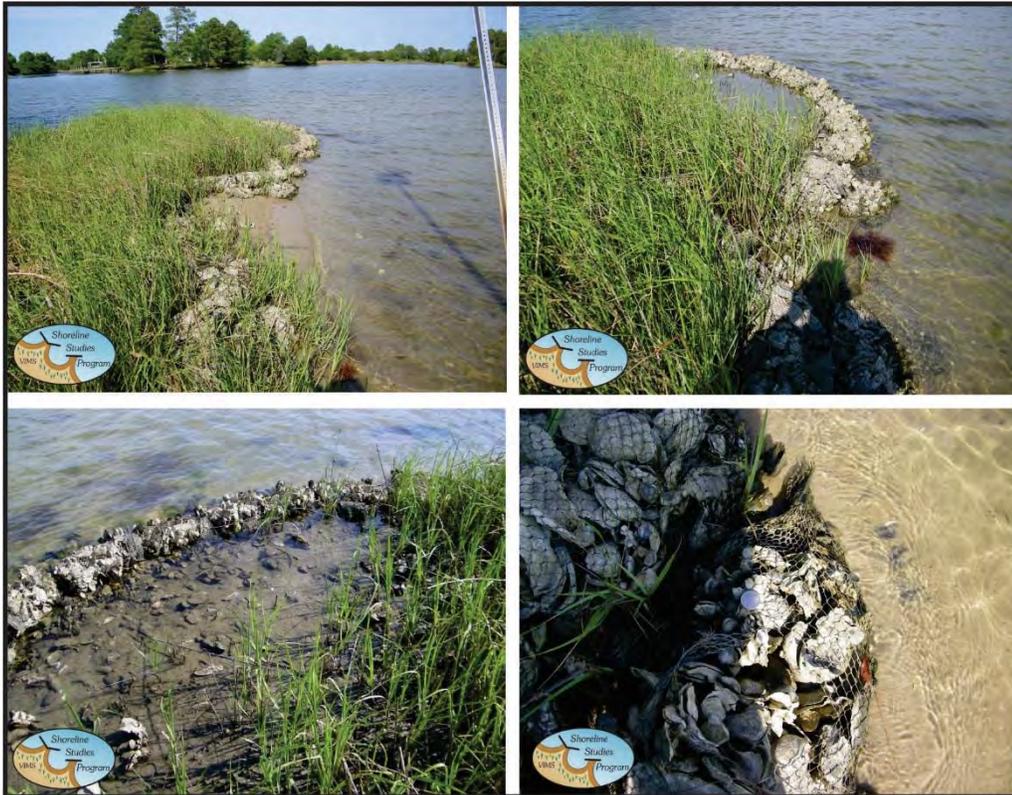
After three years, the marsh was growing in front of the bags in one section of the sill. After four years, the area behind the bags has filled in with marsh, creating a nice marsh fringe at the site that has grown in front of the bags in some areas of the project (Figure 4-15).

Figure 4-14. Oyster bag sill at Site 3, St. Johns Point on 10 May 2017 approximately 3 years after placement.

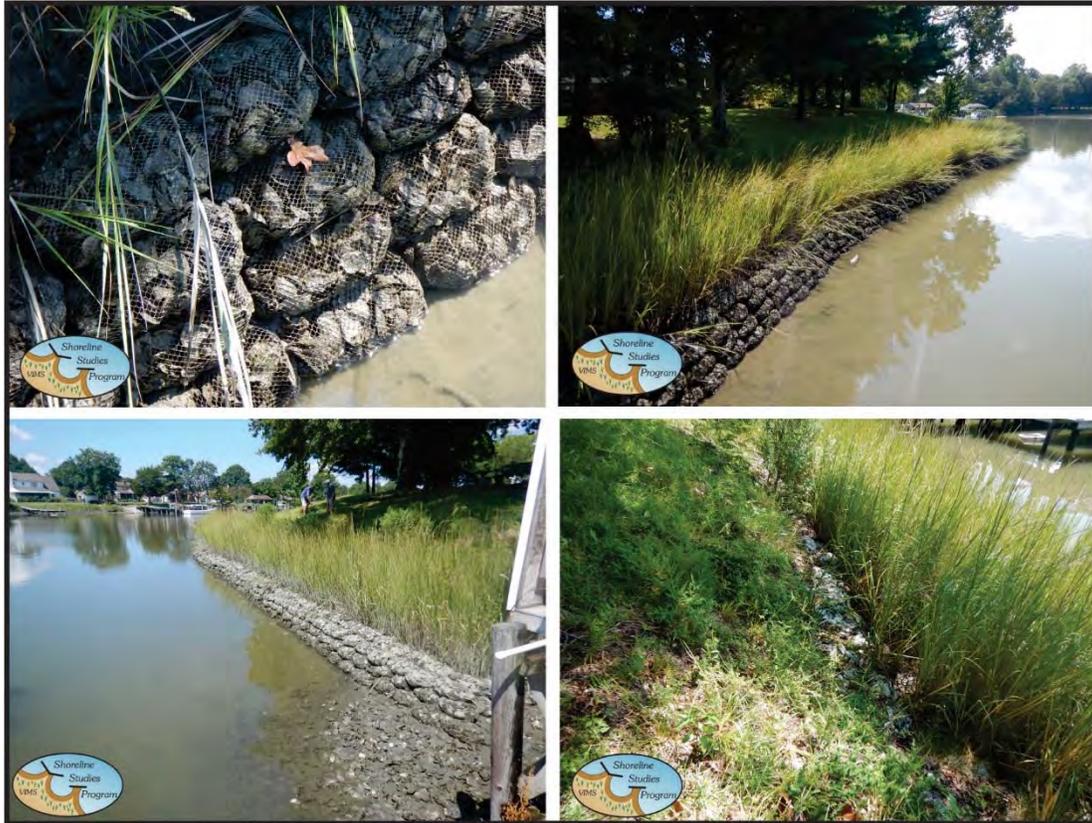
Figure 4-19. Site 4 oyster bag sill in September 2018.

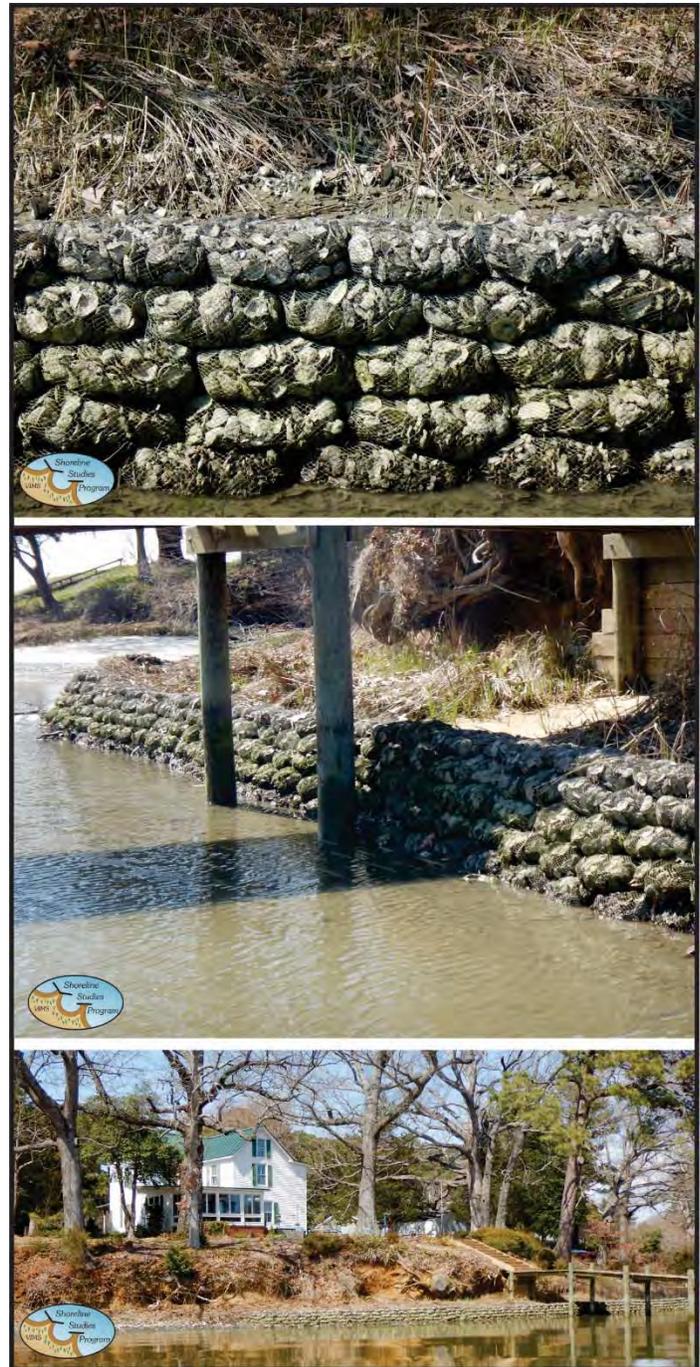
This oyster bag sill has been very successful in terms of both shore protection and habitat creation. After two years, the oyster bags are still intact, and many oysters are growing on the bags. Sediment has been deposited behind the structure, and the marsh edge is no longer scarped behind the

Figure 4-24. Site 5 on March 28, 2018. After nearly two years, the bags are still intact and have stayed as placed. Marsh has filled in behind the structure. Oysters have been recruited along the sill.

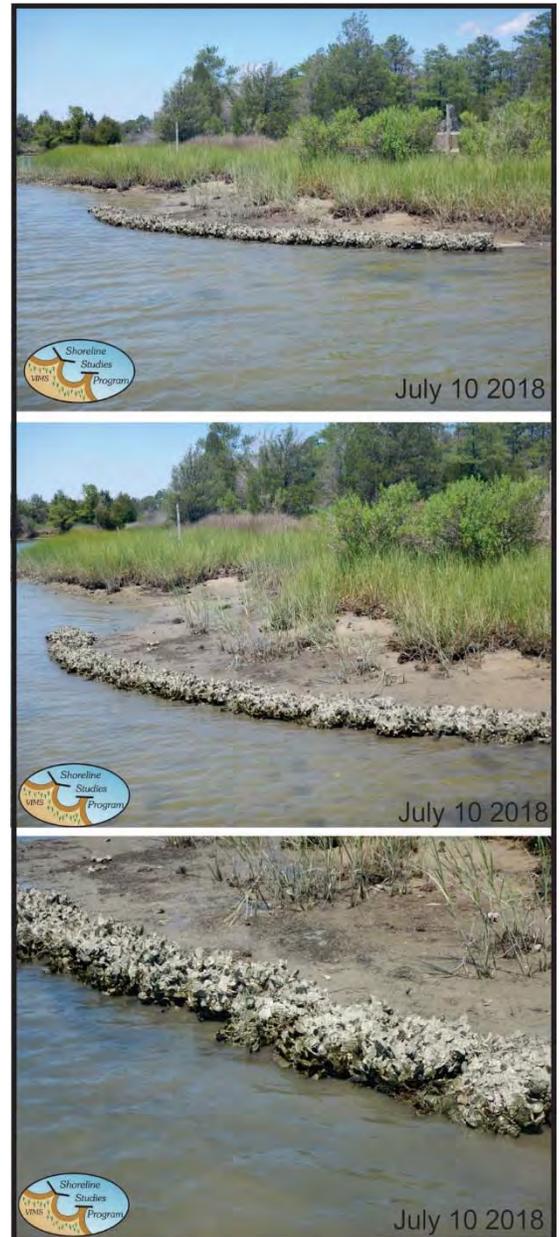
structure as it is along the marsh adjacent to the project (Figure 4-27). In addition, marsh grass runners are extending toward the sill on the newly deposited sediment.

Figure 4-27. Site 6 oyster bag sill two years after installation. The sill has provided shore protection and created habitat. A great many oysters are growing on the bags. In addition, sediment has come in behind the sill, the marsh is no longer scaped, and marsh grass runners are extending toward the sill.

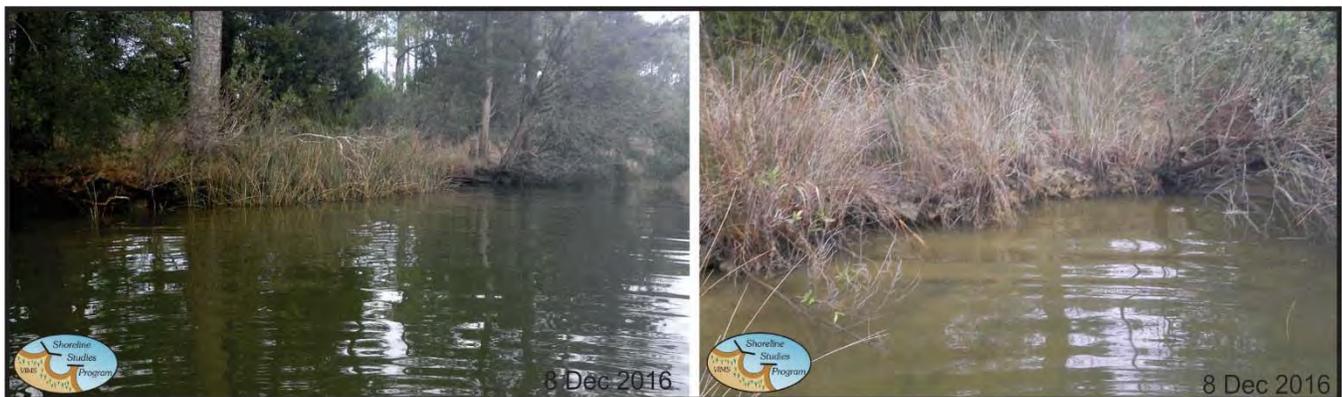
Prior to installation of the project, the upland and marsh shoreline were exposed and eroding (Figure 5-2). The oyster bag sills were placed in front of both the upland and the marsh shorelines.

Figure 5-2. Heritage Park shoreline prior to the installation of the oyster bag sill. Both marsh and upland sections of the shoreline were eroding.

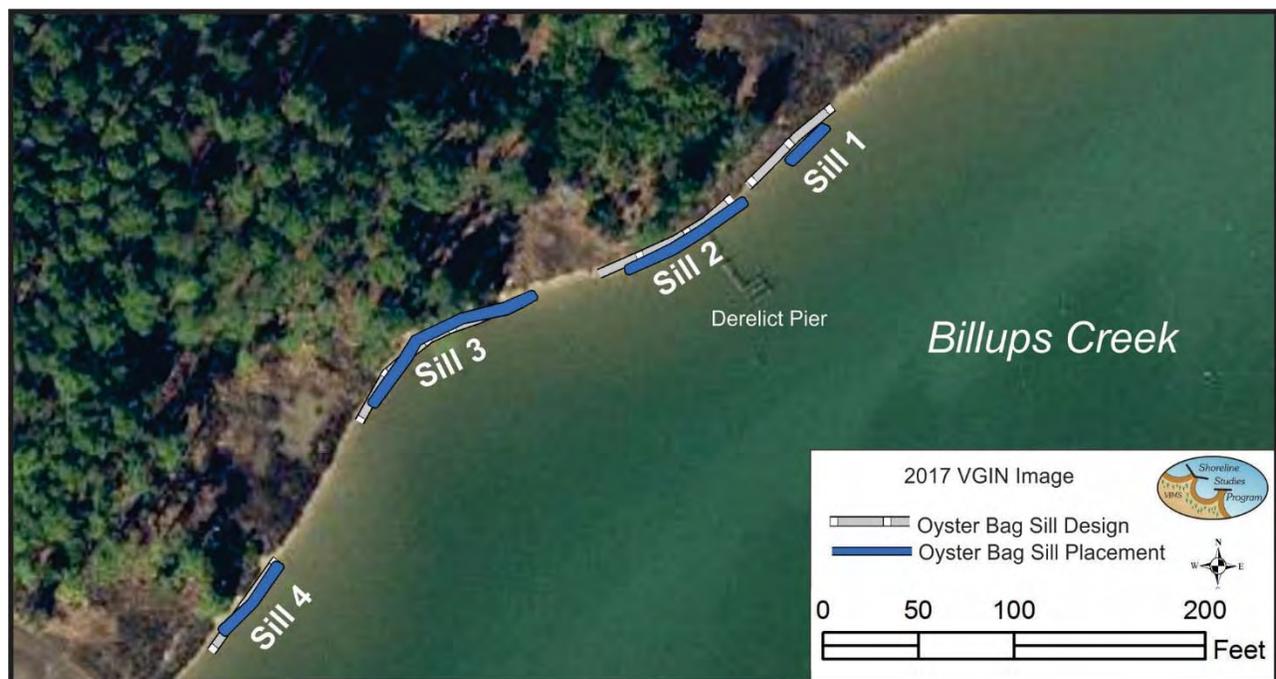
During construction, the sill design was modified somewhat based on site conditions (Figure 5-3). Sills 2, 3, and 4 were constructed as designed; however, Sill 1 was shortened slightly to create a wider gap for a kayak launch. The extra bags were placed on Sill 3. The center section of Sill 3, where it is adjacent to the upland section of shore, was built as a 5 bag sill, 3 bags on the bottom and two on the top. This widened the sill to provide more protection to the eroding upland bank.

Figure 5-3. Location of the oyster bag sills as designed (gray) and actual placement (blue).

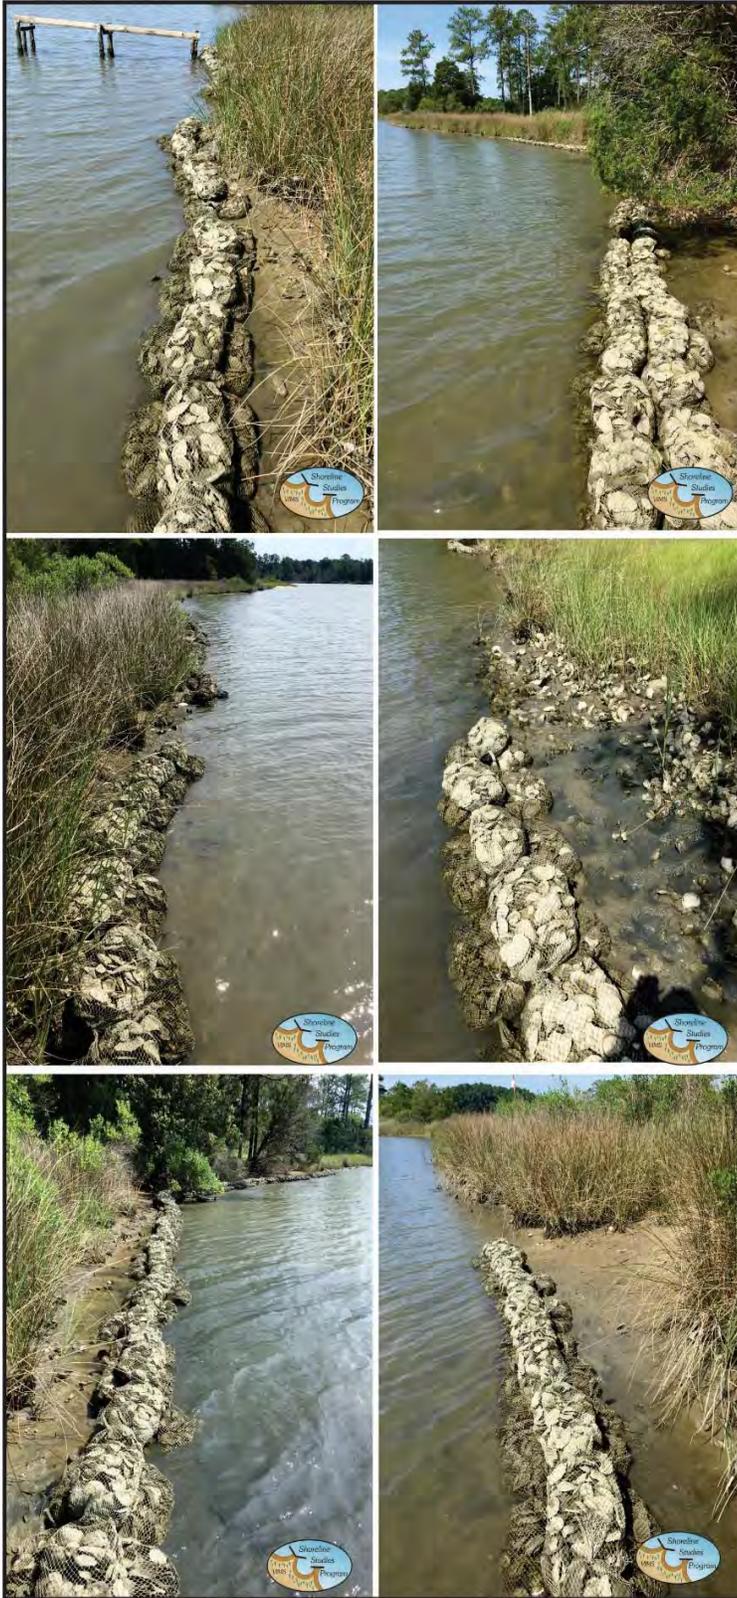
Overall, the sill has remained intact over the 1.5 years that it has been installed (Figure 5-4). The bags have remained in place with no apparent sinking or movement landward. Visual inspection determined that some fine-grained sediment is accumulating behind some sections of the structure (Appendix C) though it was not measured.

Figure 5-4. Heritage Park three months after construction (June 29, 2017).

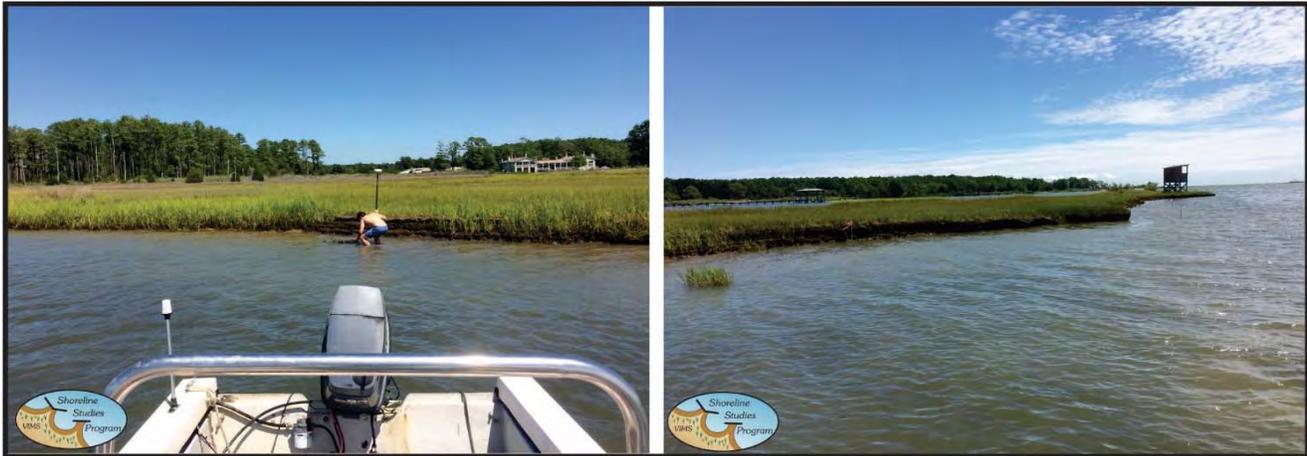
Figure 5-5. Existing shoreline along the marsh at CSRA, August 6, 2017.

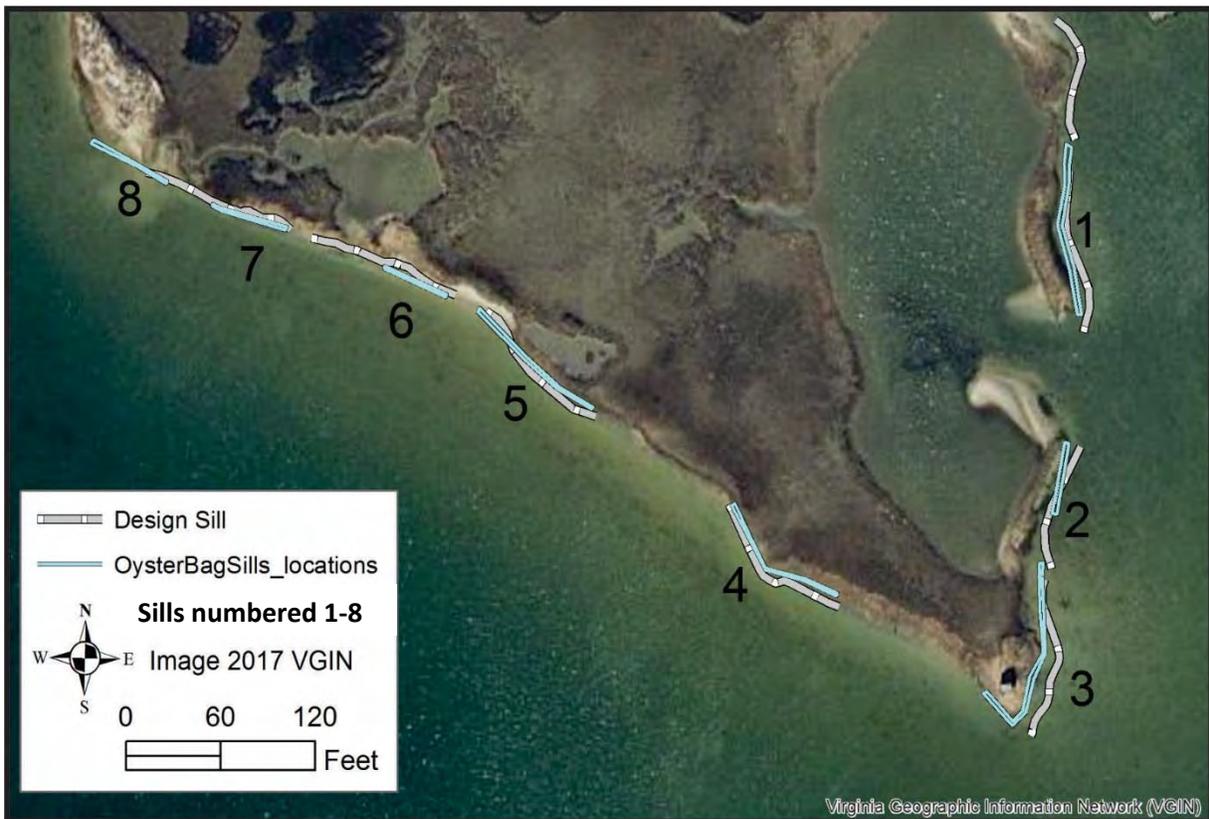
The site was surveyed by real time kinematic global positioning system on September 8, 2017 and April 3, 2018 (Appendix C). The survey shows that the oyster bags were placed similar to what was designed (Figure 5-8). However, only three sections of sill were built on the southeast facing shoreline while 5 sections were built on the southwest facing shoreline because shore conditions were different at the time of installation. The 6-bag sill was wrapped around the southernmost point very close to the marsh to provide additional protection to the area with the largest erosion rate. A duck blind is located close to the shore in this area.

Figure 5-8. Comparison between the location of the oyster bags sills (numbered 1-8) in the design (white) and what was installed (blue).

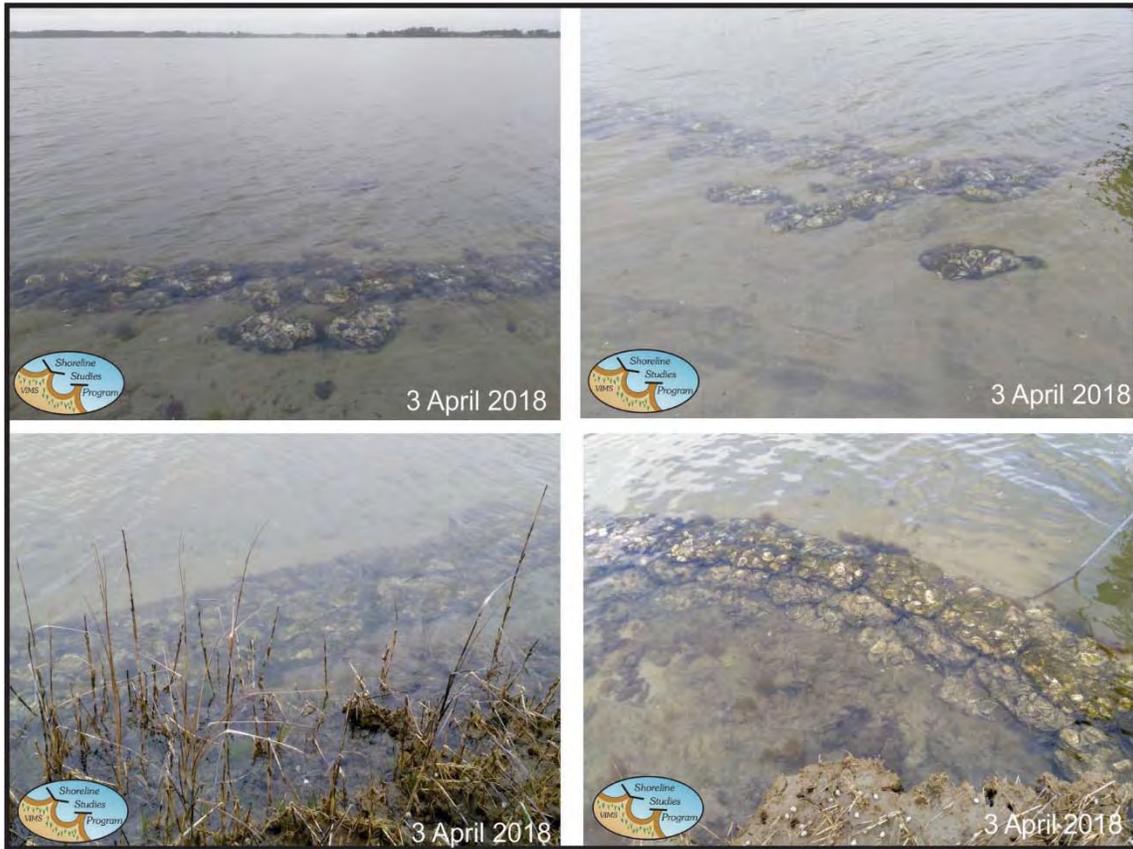
Overall, the 6-bag sill has fared very well. It has remained intact over the past year. The 3-bag sill has had mixed results. The sections of sill that are farther north, and therefore are more protected, remained intact as did those that were placed close to the marsh. However, the top bag on the 3-bag sills that were placed farther from the marsh because of the slope of the intertidal area tended to roll (Figure 5-9). This was even more noticeable in July 2018 (Figure 5-10). This section of shoreline has a higher average fetch than the existing oyster bag sills that were described in Section 4 which may account for the difference in sill structure. No definitive data has determined whether or not the change in structure will affect the role the bags play in shore protection.

Figure 5-9. The three bag sill (top) that was placed on the southwest-facing shoreline has not been as stable. The top bag of some sections were rolled toward the shoreline. The six bag sill (bottom) on the point and the southeast-facing shoreline has remained intact.

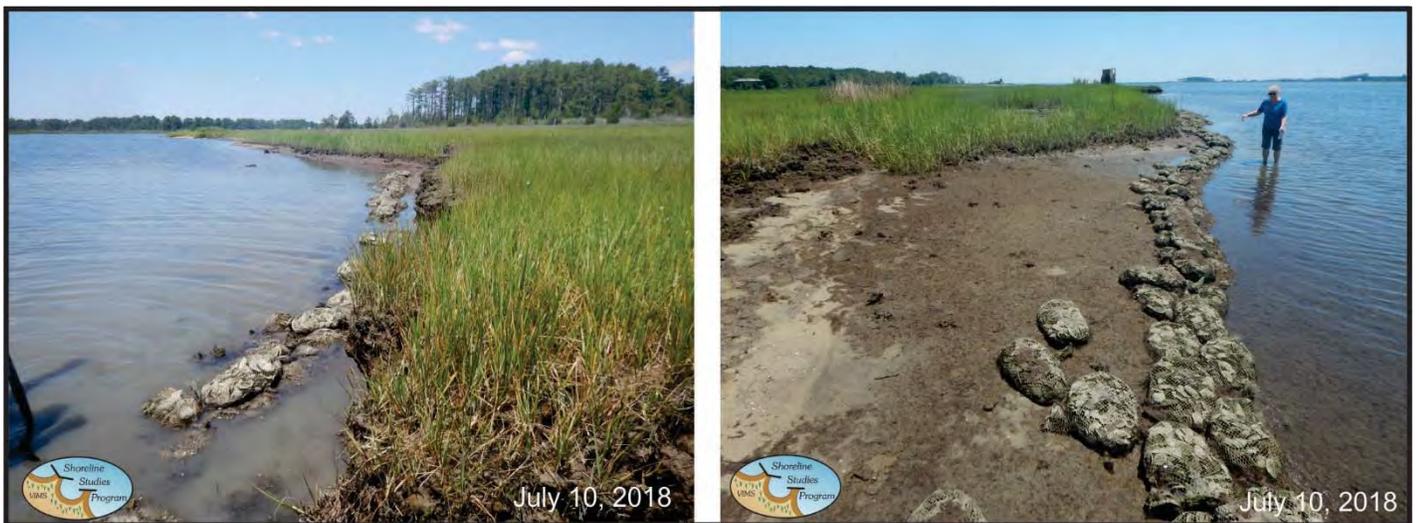
Figure 5-10. The 3-bag sill tended to remain intact when placed close to the eroding marsh scarp (left). However, when the bags are placed at low water farther from the shore because of the gentle slope of the intertidal area, they tended to roll.

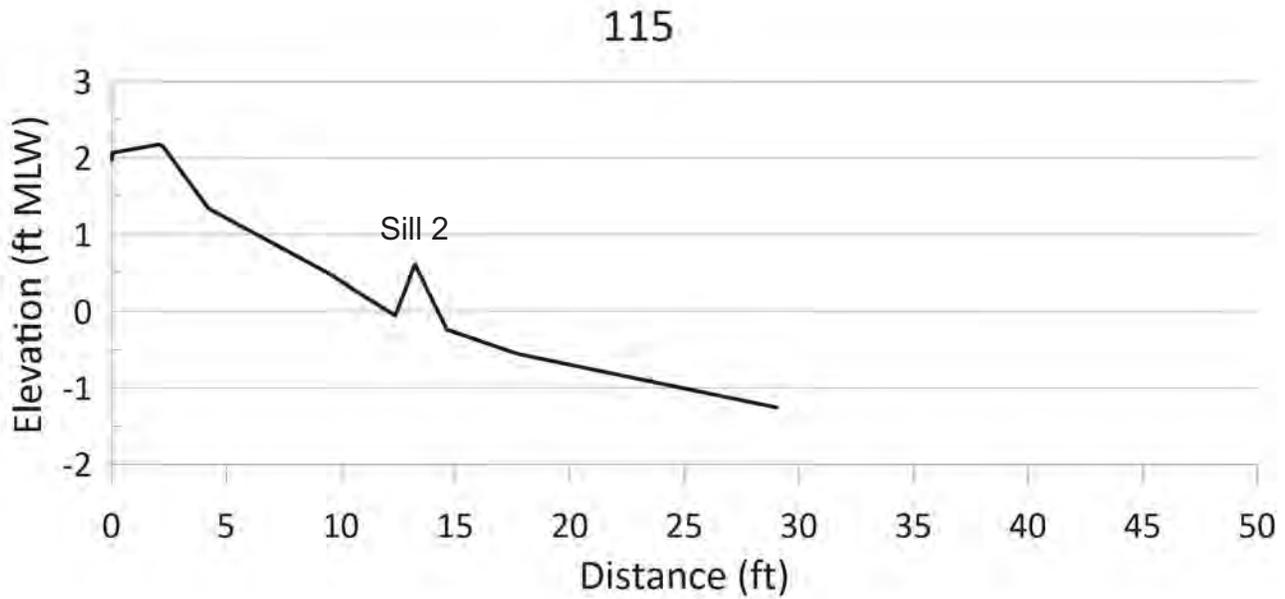
Cross-sectional profile 115 of Sill 2 fronting the upland. Survey taken 26 Jan 2018, ten months after installation. The bags were placed at about mean low water (0) and are about 0.5 ft high.

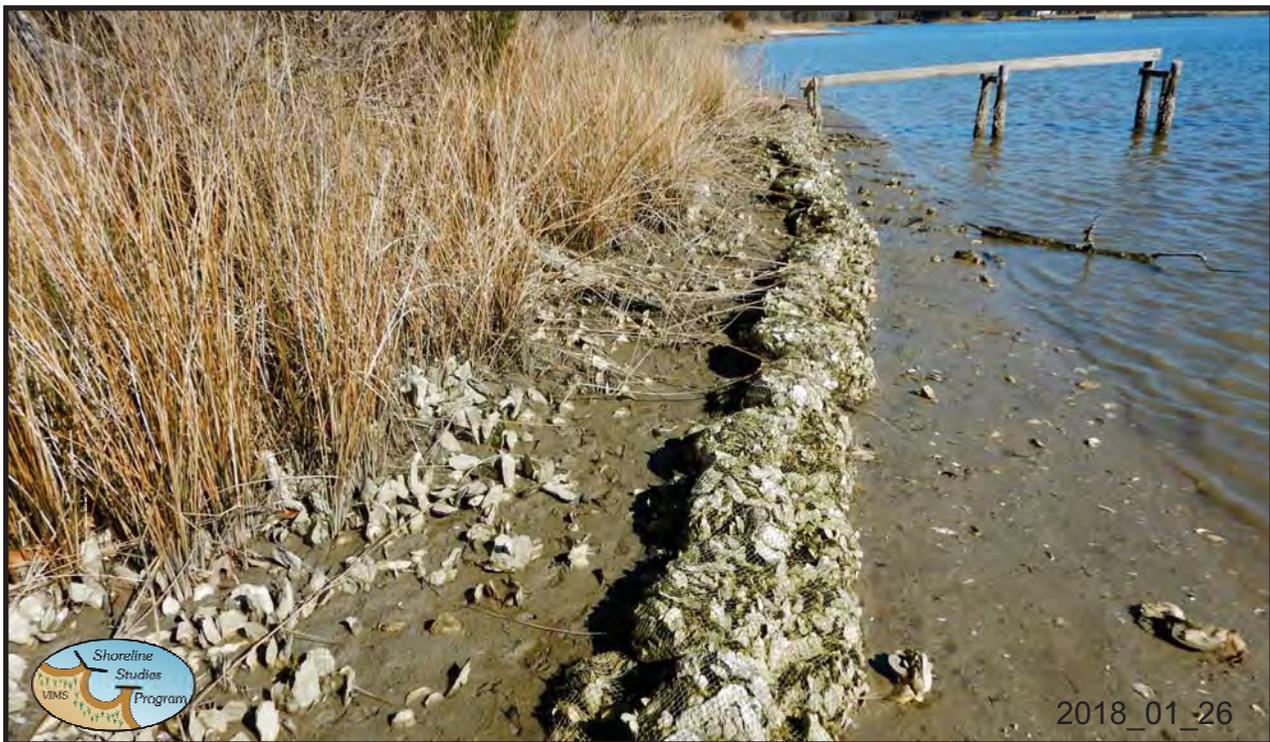
Sill 2. Some fine-grained sediment has been deposited behind the sill structure.

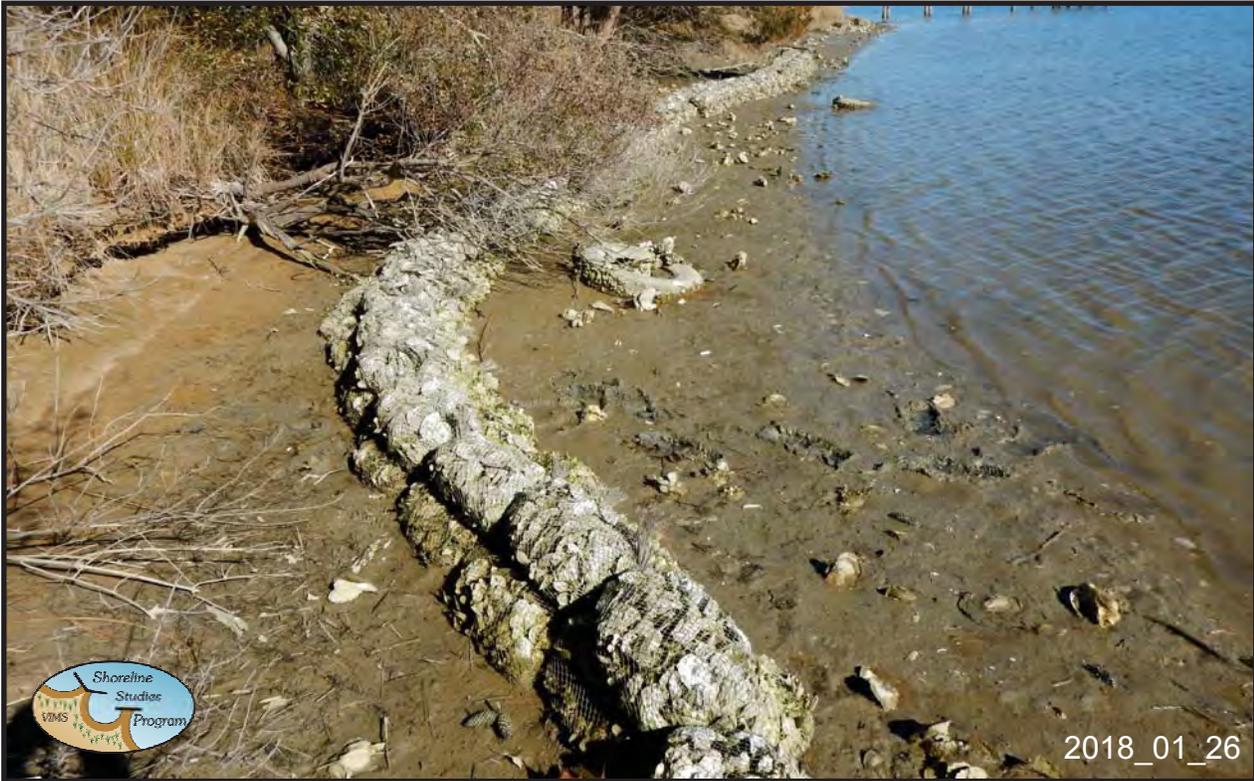
The southern end of Sill 3 flares out to follow low water.

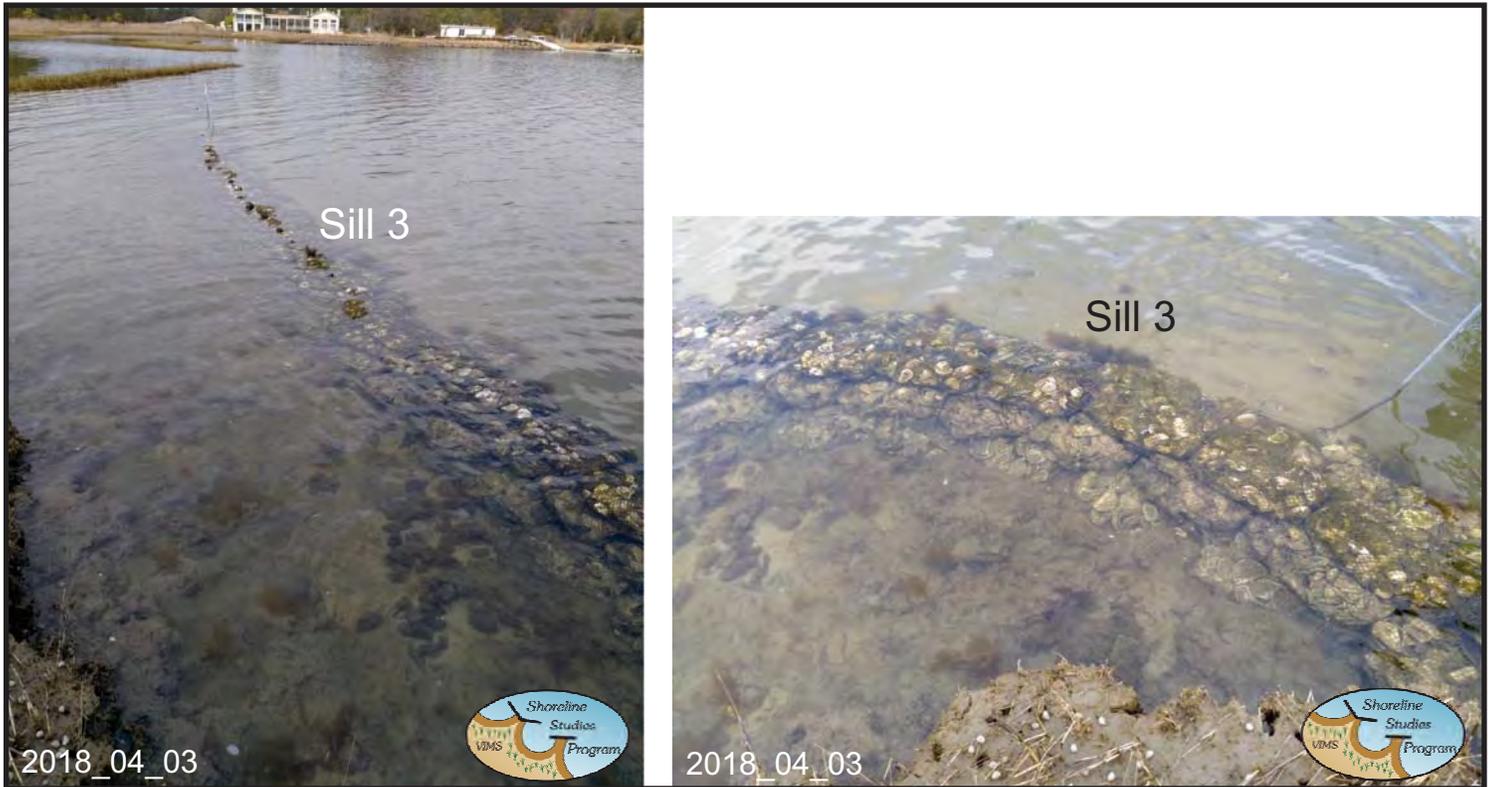
Sill 3 is a 6 bag sill on the east-facing shoreline. The bags were placed directly up against the marsh scarp at the point (Profile 683), but farther north along the shoreline, the sill moves away from the shoreline to follow because mean low water is farther offshore.

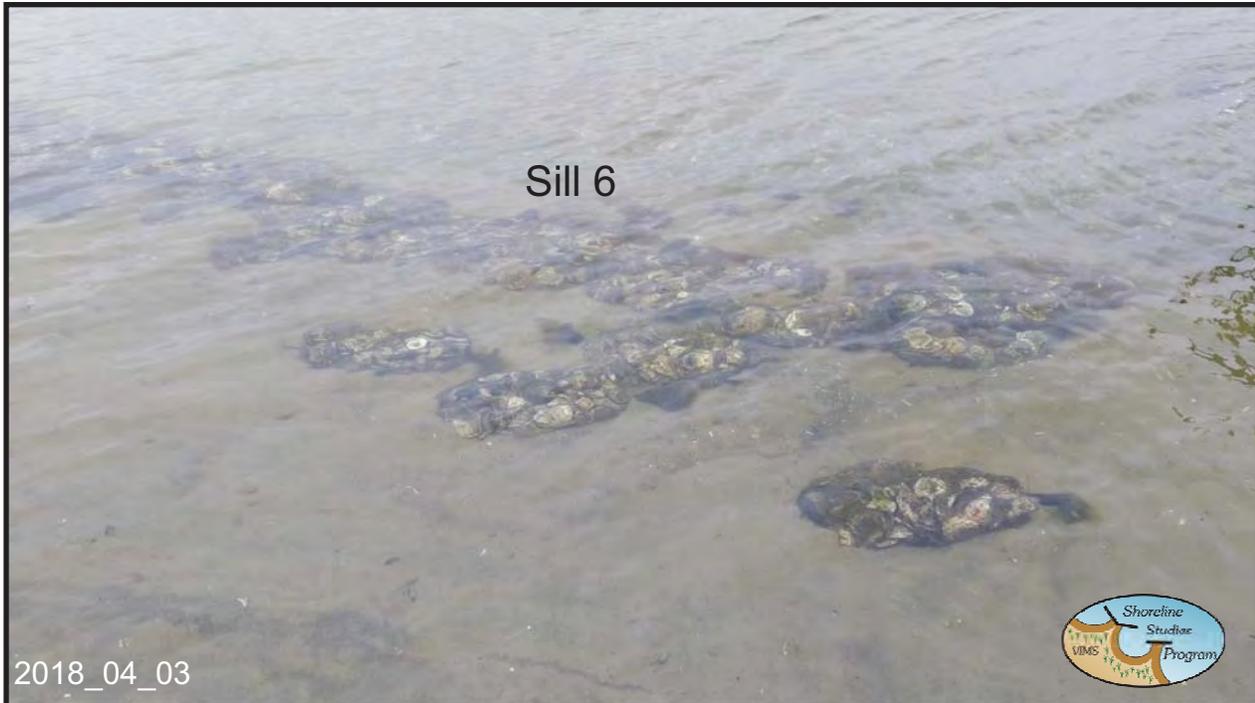
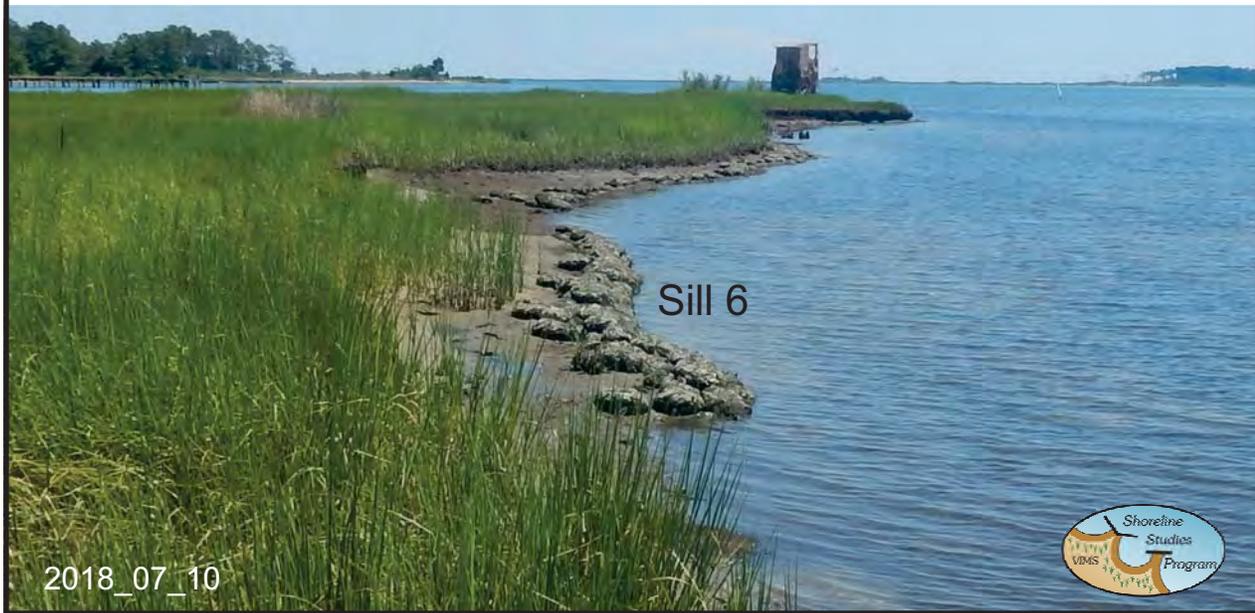
The bags in sill 6 did not maintain their structure. The bags were farther offshore and rolled in toward the marsh.

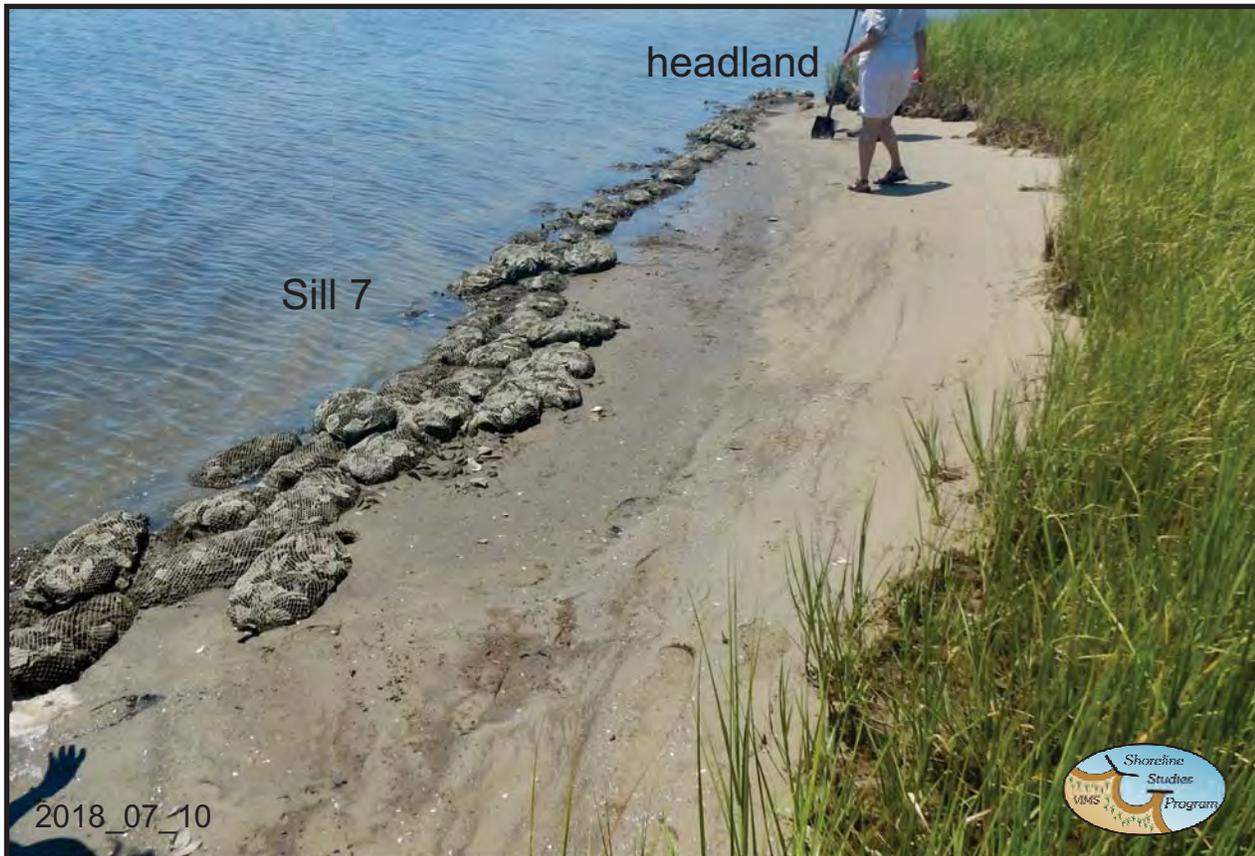
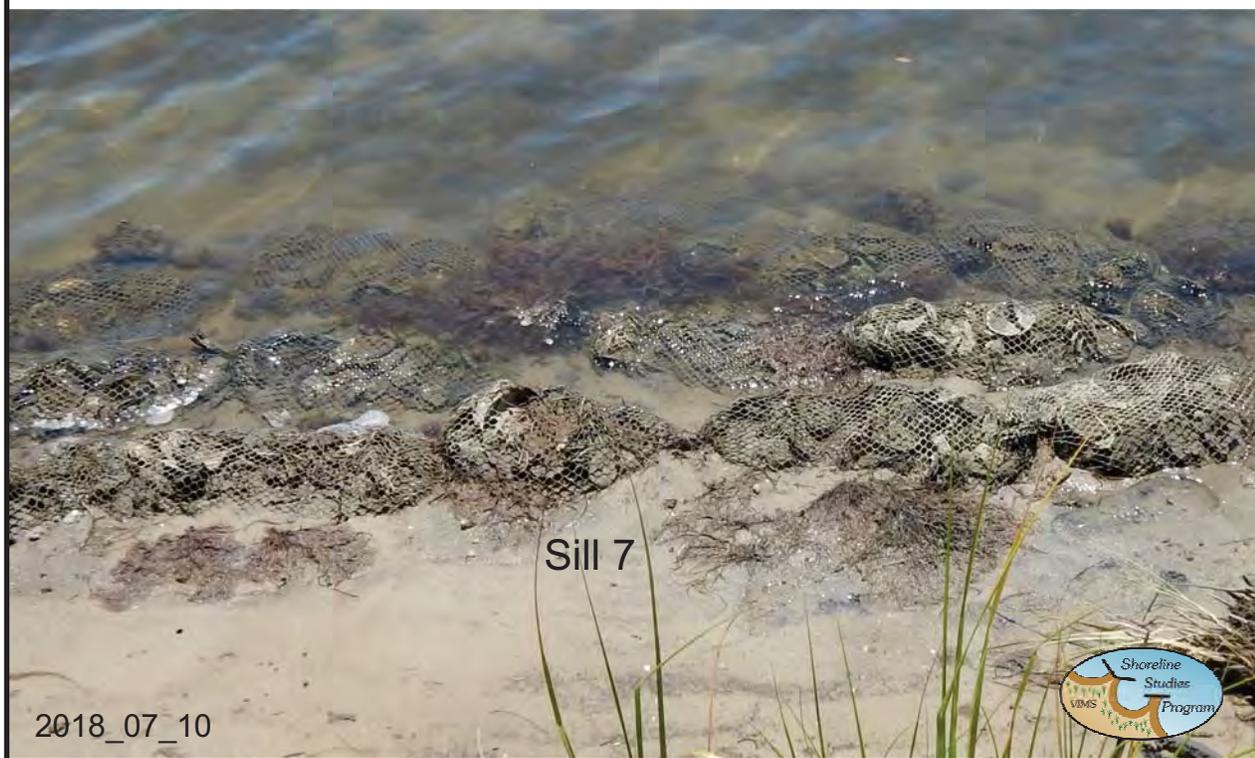
Sill 7 also had bags that rolled toward the marsh. Next to the headland, where the sill is closer to the marsh, sediment has been deposited landward of the bags.

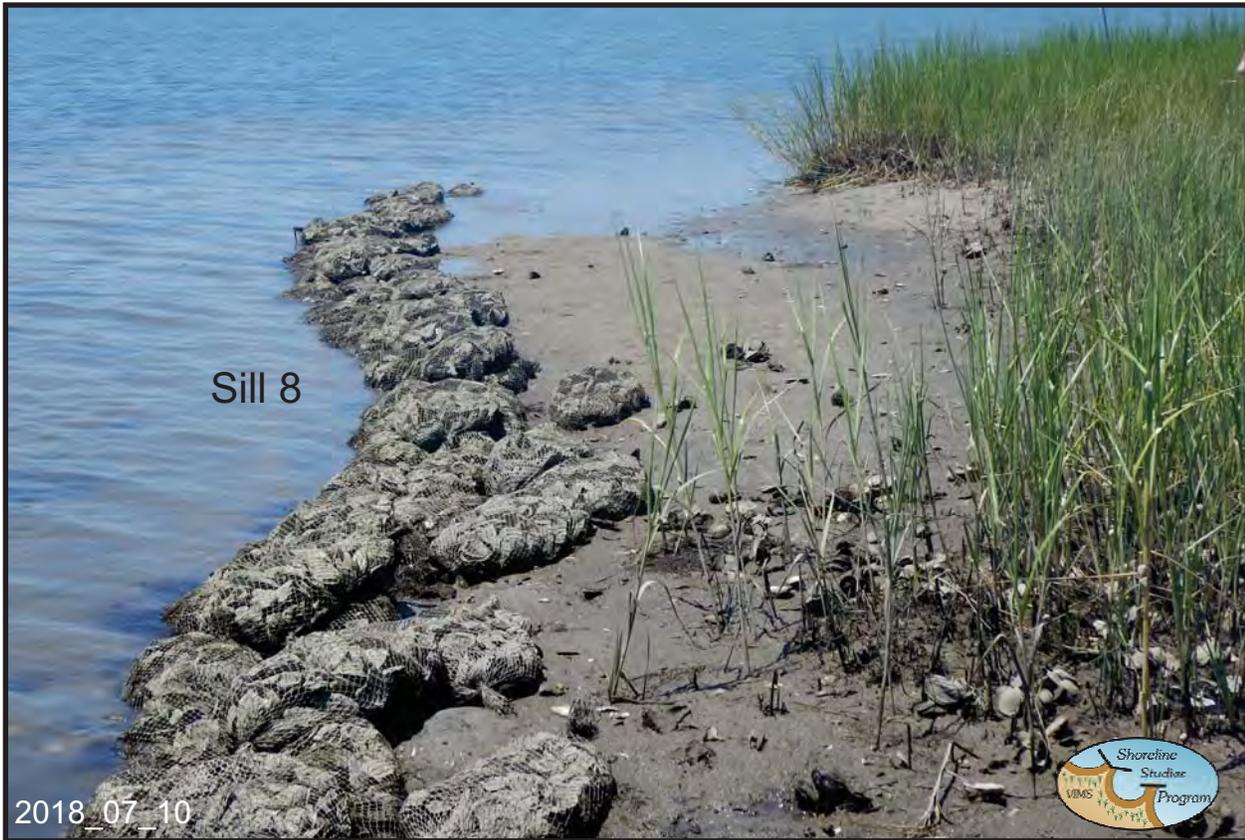
At Sill 8, sediment has been deposited behind the oyster bag sill allowing marsh grasses to grow riverward.
