*Oyster Bag Sill Construction
and Monitoring at Two Sites
in Chesapeake Bay*

Oyster Bag Sill Construction and Monitoring at Two Sites in Chesapeake Bay

Virginia Institute of Marine Science

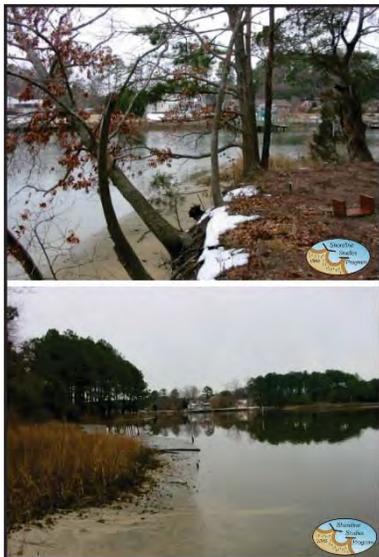
Figure 4-3. Site 1 before project installation. The marsh is eroding and an upland bank is exposed and eroding. Photo credit: VMRC permit application uploaded 28 Oct 2010.

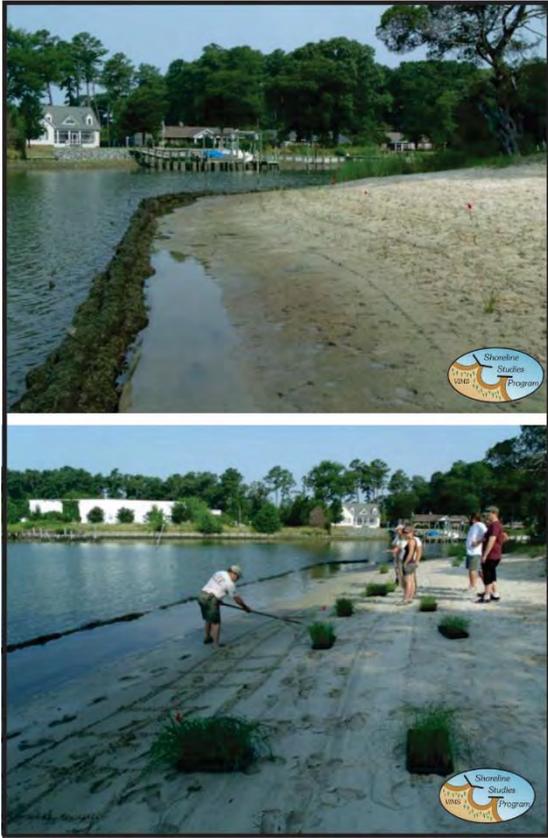
Figure 4-5. Post bag and sand installation at Site 1. The sand fill is visible landward of the sill, and volunteers planted grasses on the fill. Photo credit: Walter Priest, 29 June 2011.

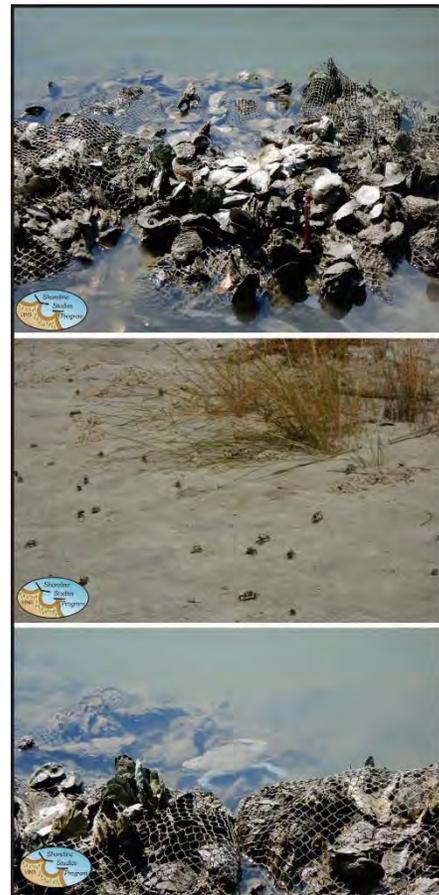
(Figure 4-6). Additional sand may have been placed along the shoreline. A site visit in 2016 showed that the sand came up to the back of the sill and was not planted in grass (Figure 4-8). The grass also may be controlled with herbicides as indicated by the brown grasses (Figure 4-7); however, that cannot be confirmed.

Figure 4-7. Fauna visible at Site 1 oyster bag sill. Juvenile fish also were visible.

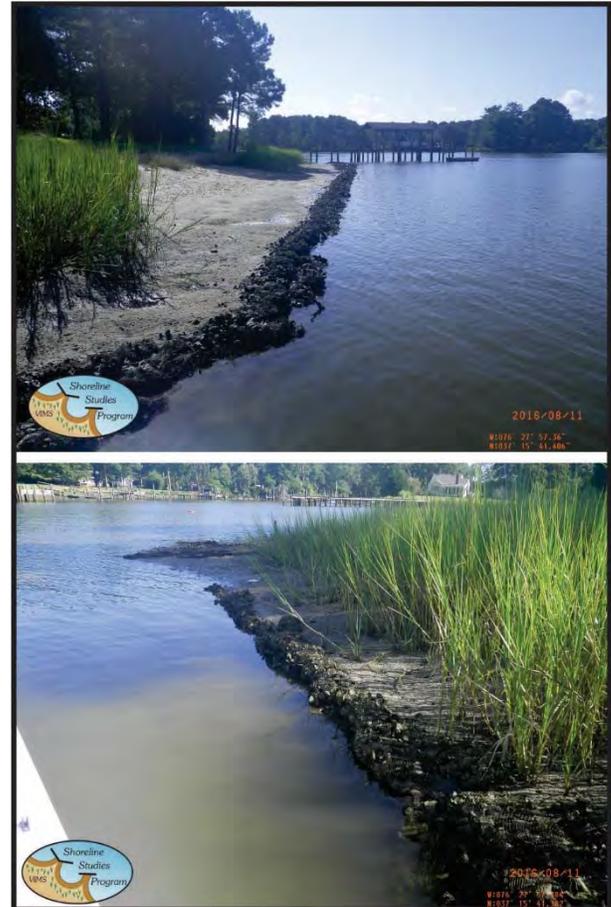
This project has been successful both in terms of habitat creation, shellfish recruitment, and shore protection. This site has been through Hurricane Sandy in 2012 and Matthew in 2016. However, maintenance sand may have been placed, and the plants have not filled in the bare area along the shoreline.

Figure 4-8. Site 1 shown in 2016 approximately four years after installation.

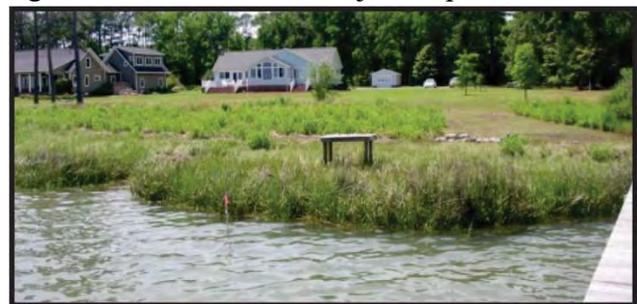
The Site 2 project is located on the York River behind Allens Island (Figure 4-9). Before the project, the site shoreline consisted of an exposed marsh (Figure 4-10). Though the site is on the York River, it is protected by the Allens Island marsh and generally has a low erosion rate (0 to -1 ft/yr) and average fetch of less than 1 mile. Approximately 201 linear feet of marsh toe oyster bag sill was installed in 2012. Bags were placed by hand in stacks of three (Figure 4-11). An oyster castle also was incorporated into the site. The project impacted approximately 657 ft² of nonvegetated wetlands.

Figure 4-10. Site 2 before project installation. Because tide level is up, the eroding marsh cannot be seen. Photo credit: VMRC permit application uploaded 6 June 2012.

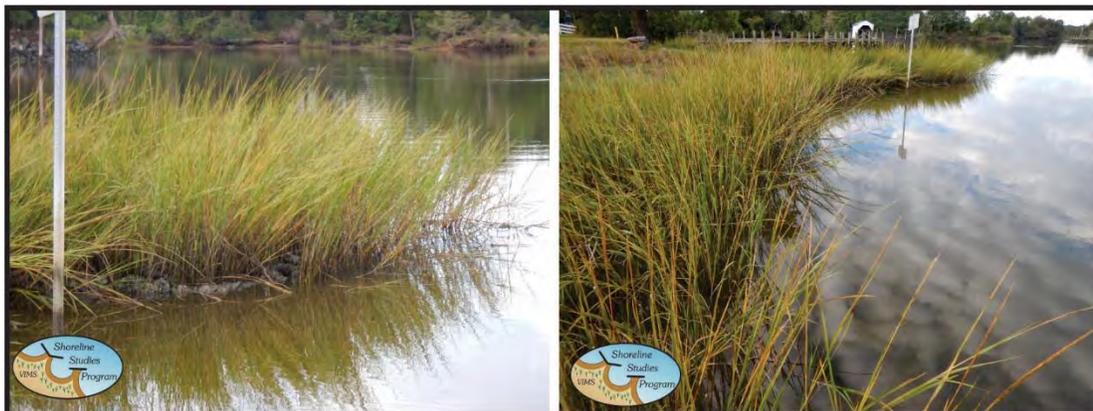
After three years, the marsh was growing in front of the bags in one section of the sill. After four years, the area behind the bags has filled in with marsh, creating a nice marsh fringe at the site that has grown in front of the bags in some areas of the project (Figure 4-15).

Figure 4-15. Oyster bag sill at Site 3, St. Johns Point in September 2018 approximately 4 years after placement.

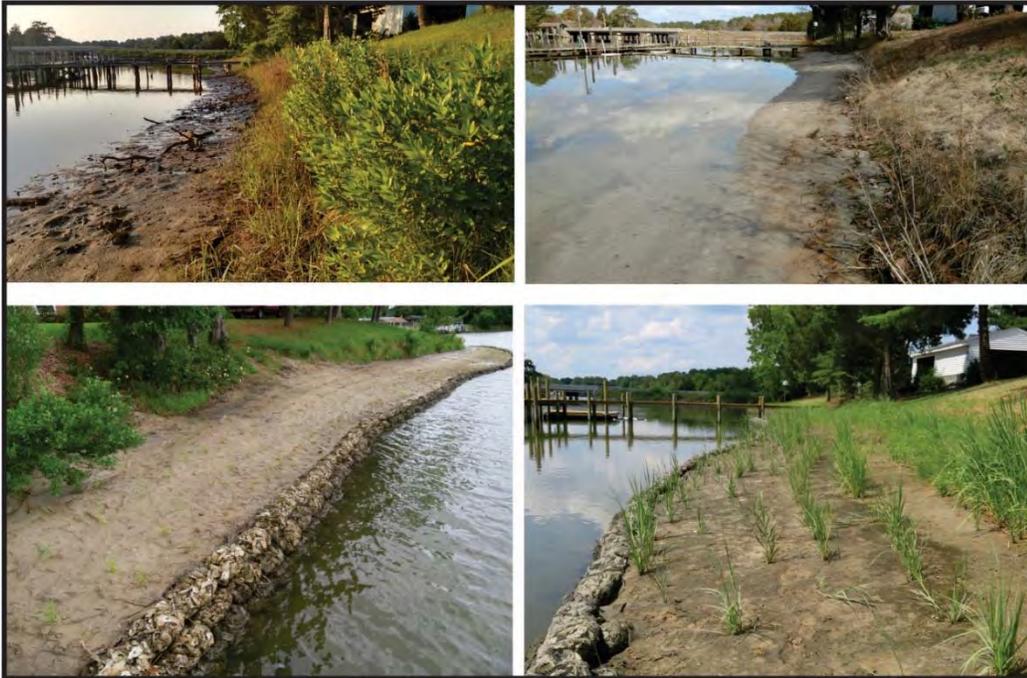
Figure 4-17. Site 4, Top left: Shoreline prior to the project on 26 May 2016; Top right: May 2017 prior to the bags being placed; Bottom left: after bags were placed in May 2017; and lower right: after the grass was planted in July 2017. Photo credit: Walter Priest.

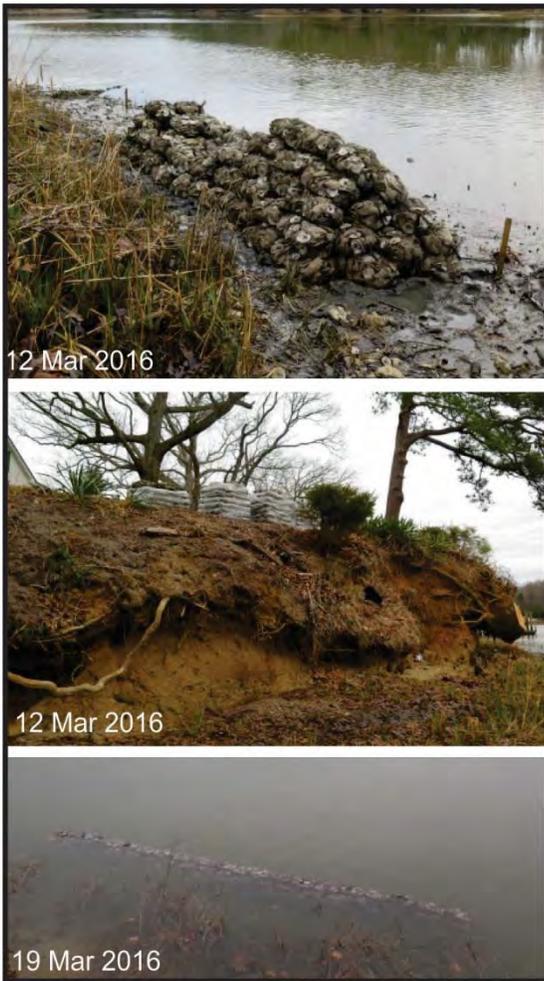
Site 5 is located on Cedar Bush Creek in Gloucester County (Figure 4-20). Cedar Bush is a small tributary to the York River. It is very shallow in the area of Site 5 with depths being less than 3 feet mean low water. Facing southeast, the site has a very low fetch. However, prior to the project, the site had an eroding upland bank and narrow fringing marsh in some areas (Figure 4-21). The site was constructed in summer 2016 and

Figure 4-21. Site 5 during construction. Top: the bags are stacked in a 15 bag triangle at low water. Middle: the eroding upland bank was not graded. Bottom: the sill under high water. Photo credit: VMRC permit application.

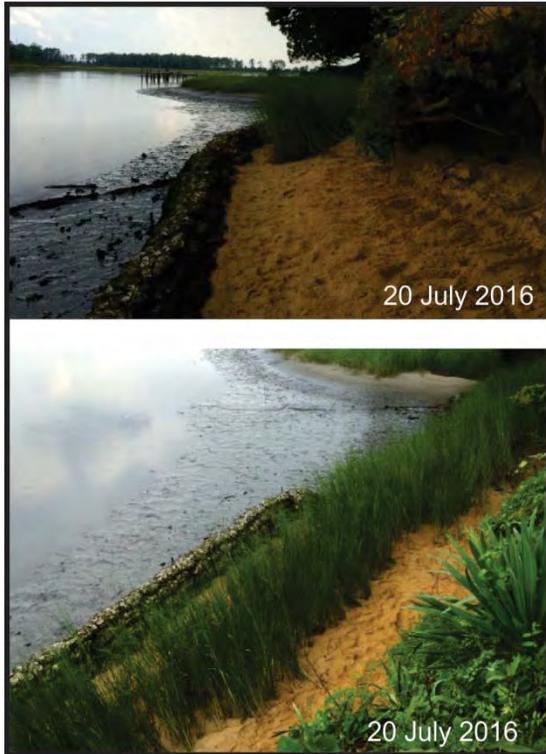
consisted of a 15 bag triangle configuration (five bags at the base) from mean low water shoreward along 170 linear feet (Figure 4-22). Approximately 128 cy of sand was pushed over the bank by bobcat, and *Spartina alterniflora* planted (Figure 4-23). No bank grading occurred, and the bank is being allowed to slough naturally. Overall encroachment was 24 ft from mean high water.

Figure 4-23. Site 5 during construction. Top: Sand was placed along the shoreline. Bottom: Marsh grass was planted. Photo credit: VMRC permit application.

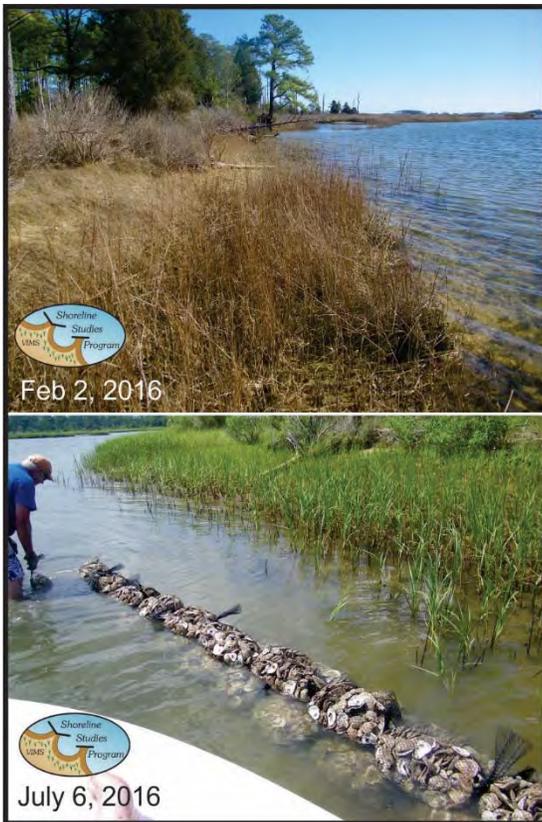
As part of a National Fish and Wildlife Foundation grant, VIMS Shoreline Studies Program installed a small oyster bag sill along Whittaker Creek as a test site (Figure 2-4). The site was an eroding marsh scarp that had a very low erosion rate (Figure 4-25). The average fetch was low, but the longest fetch is over a mile. The site was stabilized with a 3-bag oyster sill approximately 60 feet long (Figure 4-26). No additional marsh grass was planted. The bottom was very soft and the lower layer of bags had to be installed to walk on to place the rest of the bags (Figure 4-25).

Figure 4-25. Site 6 Top: prior to installation, the site had an eroding marsh. Bottom: a 3-bag oyster bag sill was installed in July 2016.

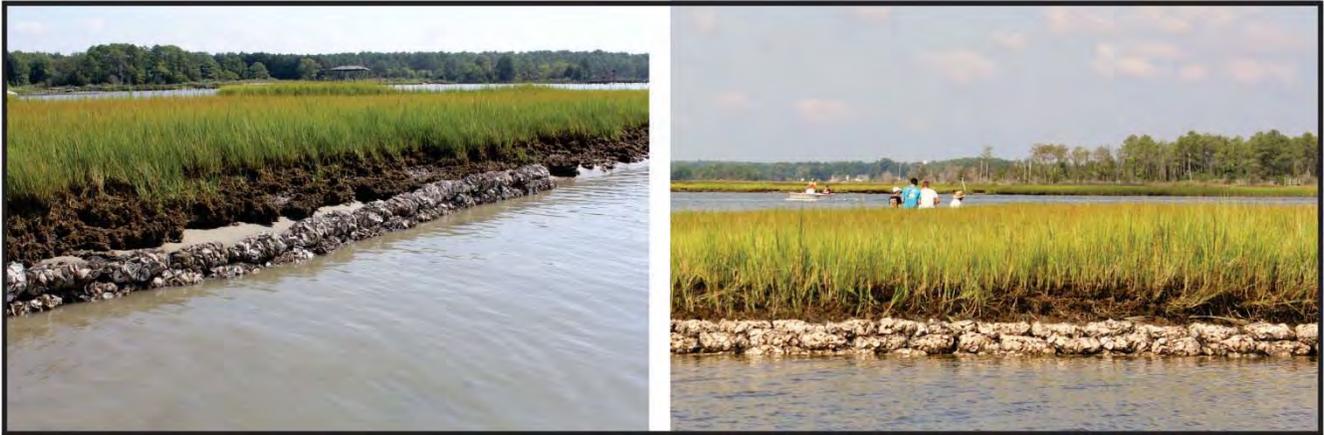
The 2,000 oyster bags were placed on August 15-16, 2017 by VIMS, Shoreline Studies Program personnel with the assistance of representatives from the Department of Conservation Shoreline Advisory Service and the Virginia Marine Resources Commission. In addition, several local teens and young adults volunteered to build the sill. Oyster bags were loaded offsite and brought by boat to the marsh for placement (Appendix A). The bags were placed directly adjacent to the eroding marsh in deeper areas and slightly offshore in more shallow areas so that the structure was at approximately low water (Figure 5-7). This would provide an intertidal range for the sill.

Overall, the 6-bag sill has fared very well. It has remained intact over the past year. The 3-bag sill has had mixed results. The sections of sill that are farther north, and therefore are more protected, remained intact as did those that were placed close to the marsh. However, the top bag on the 3-bag sills that were placed farther from the marsh because of the slope of the intertidal area tended to roll (Figure 5-9). This was even more noticeable in July 2018 (Figure 5-10). This section of shoreline has a higher average fetch than the existing oyster bag sills that were described in Section 4 which may account for the difference in sill structure. No definitive data has determined whether or not the change in structure will affect the role the bags play in shore protection.

Figure 5-7. Construction of the 3-bag sill (left) and 6-bag sill (right). Photo credit: Linda Tjossem.

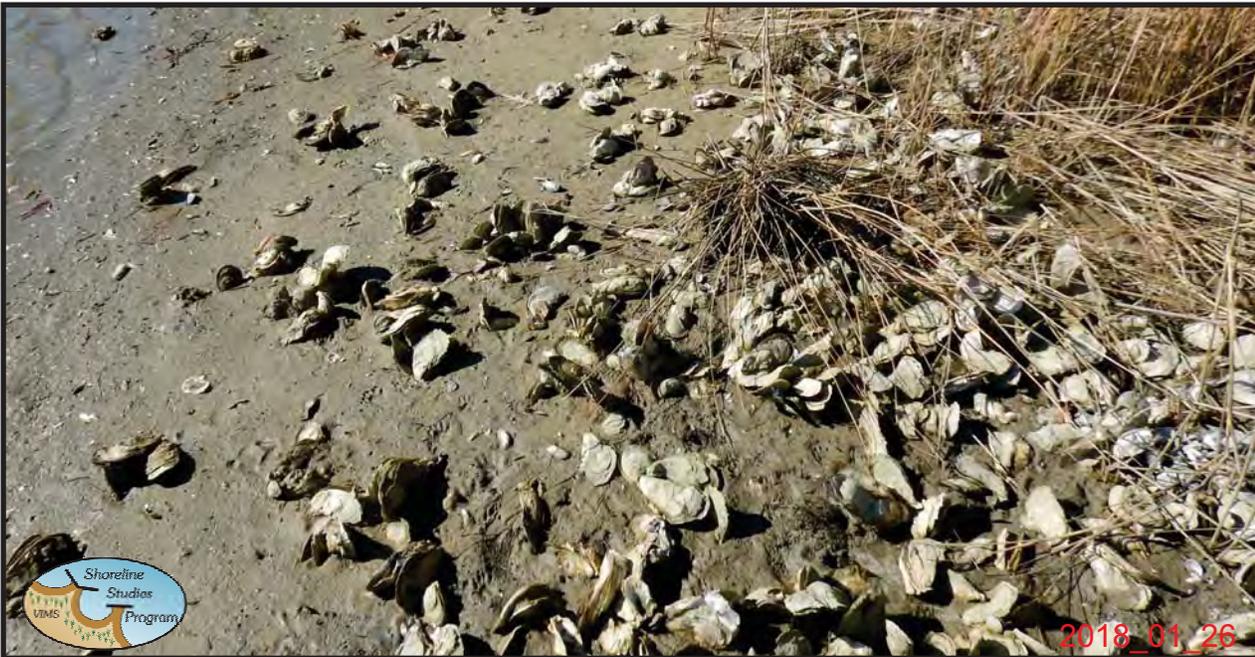
Oysters occur naturally in large numbers along this shoreline.

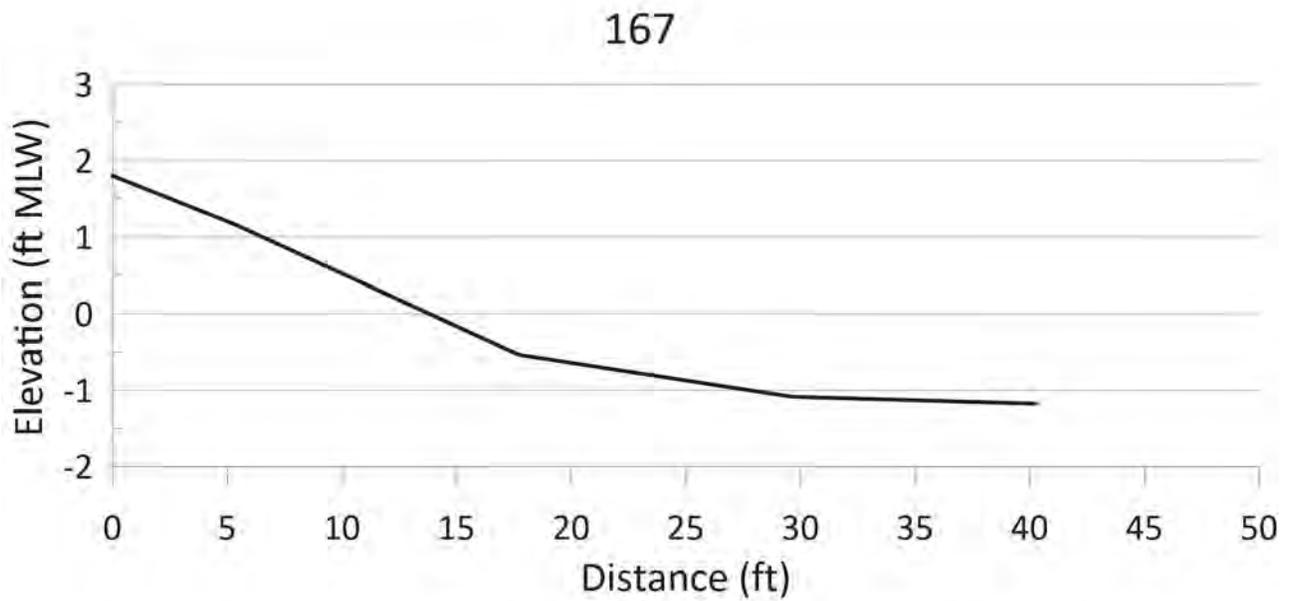
Cross-sectional profile 167 of the shoreline between Sill 2 and 3 in the marsh. Survey taken 26 Jan 2018, ten months after installation.

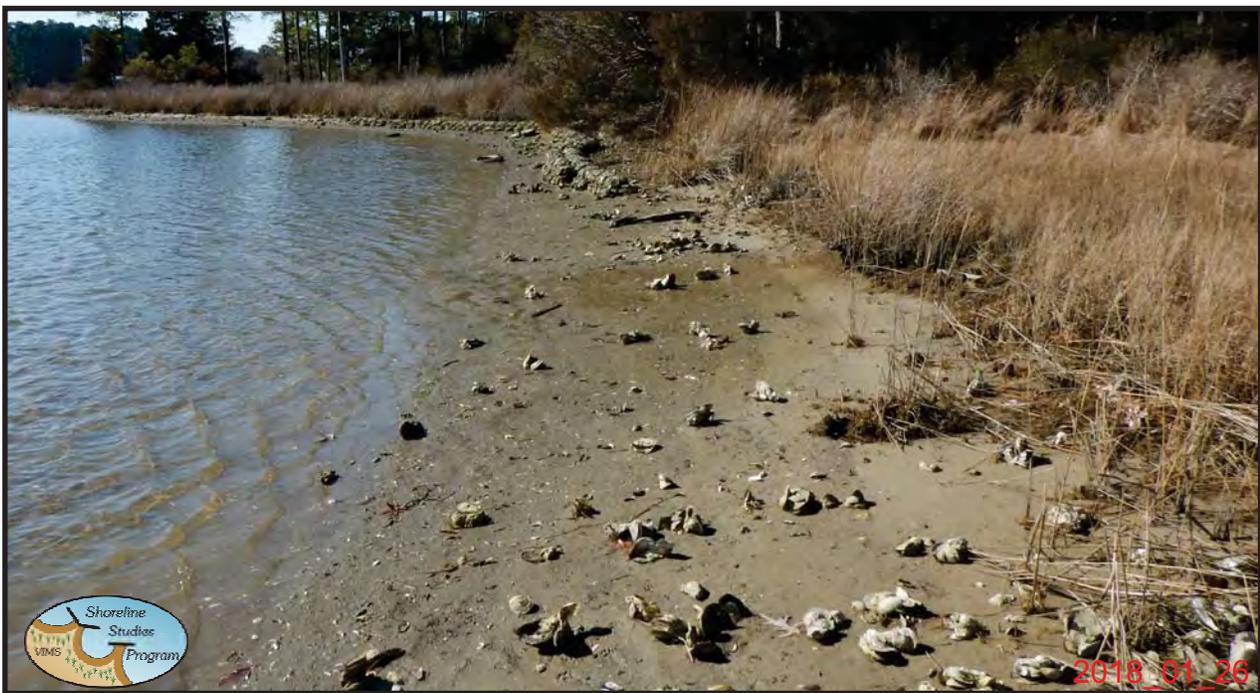
The shoreline between Sill 2 and 3 in the marsh looking toward Sill 3.

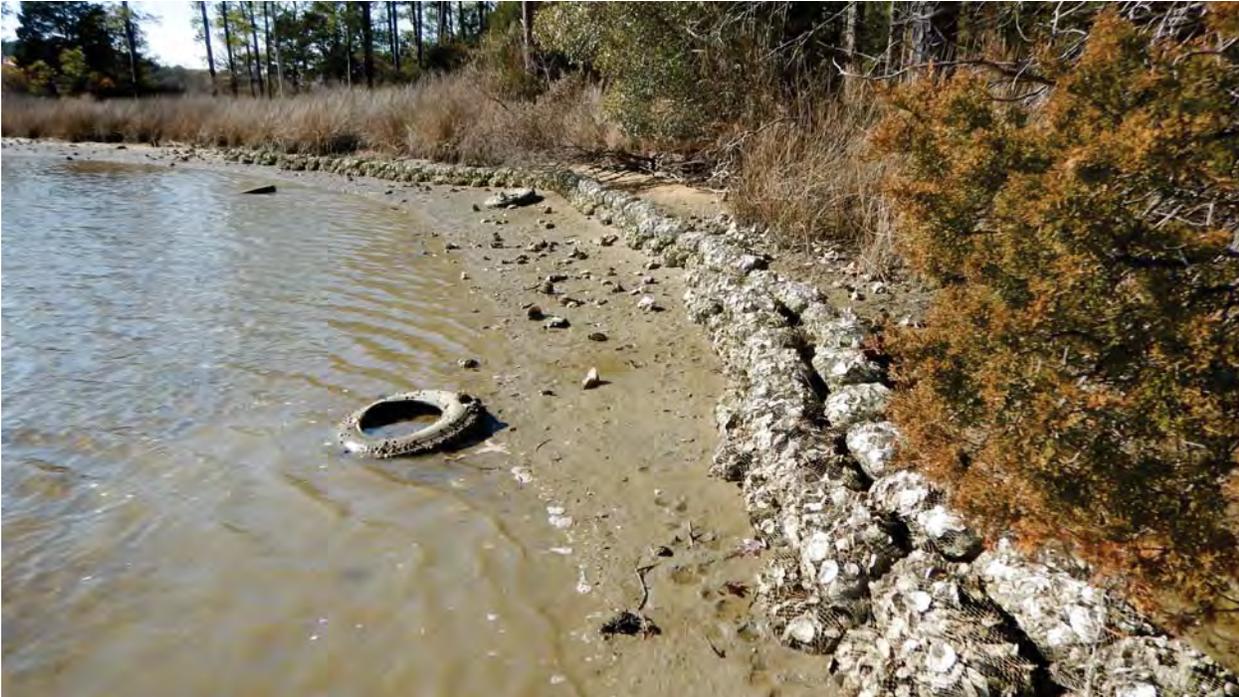
The middle section of Sill 3 was built as a 5 bag sill, 3 bags on the bottom and two on top, because it fronted a section of eroding upland. The ends of Sill 3 are 3 bag sills.

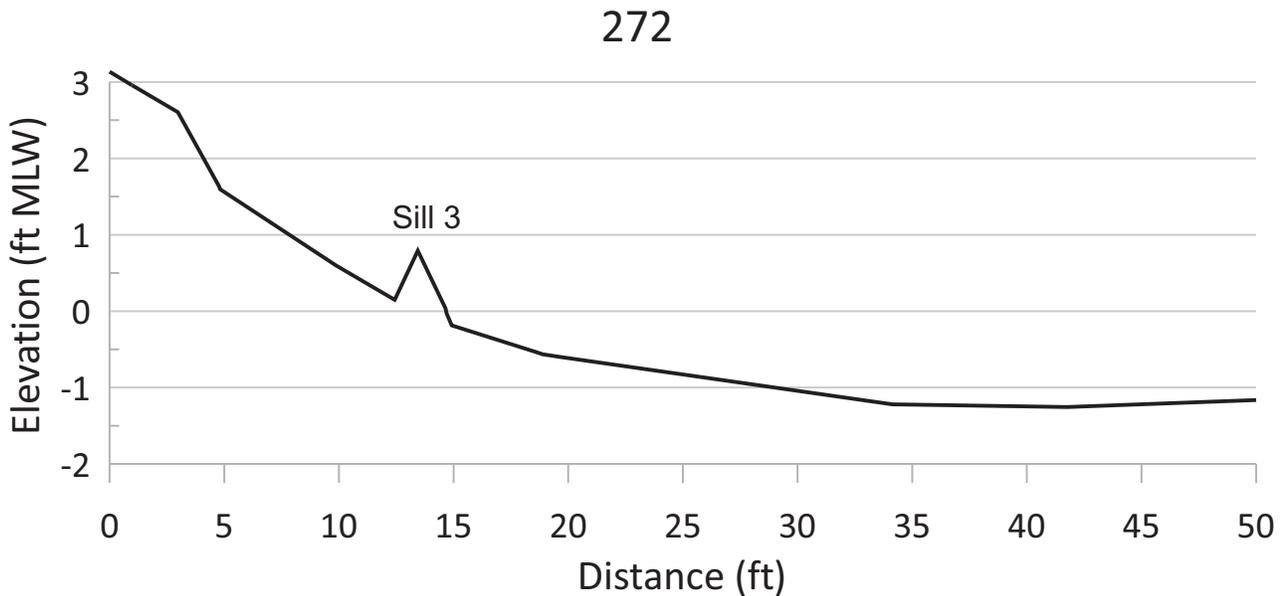
Cross-sectional profile 272 of the 5 bag section of Sill 3. Survey taken 26 Jan 2018, ten months after installation.

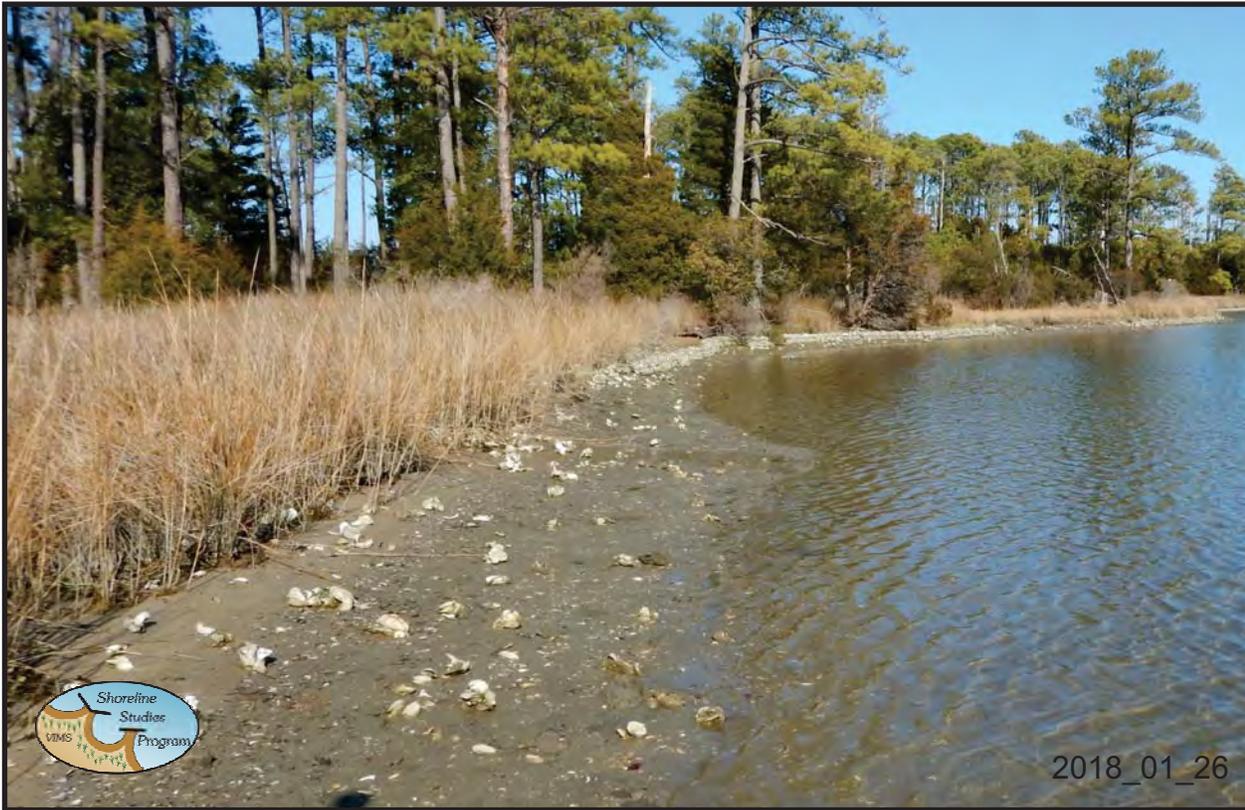
The marsh shoreline between Sills 3 and 4.

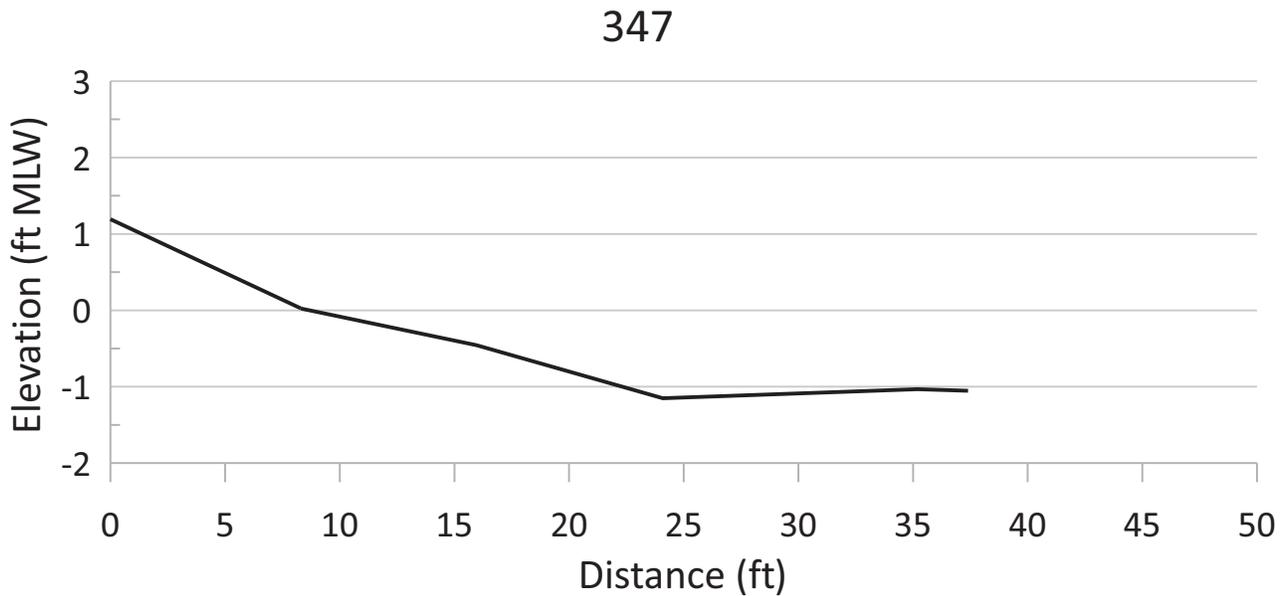
The cross-sectional profile for the shoreline between Sills 3 and 4. Survey taken 26 Jan 2018, ten months after installation.

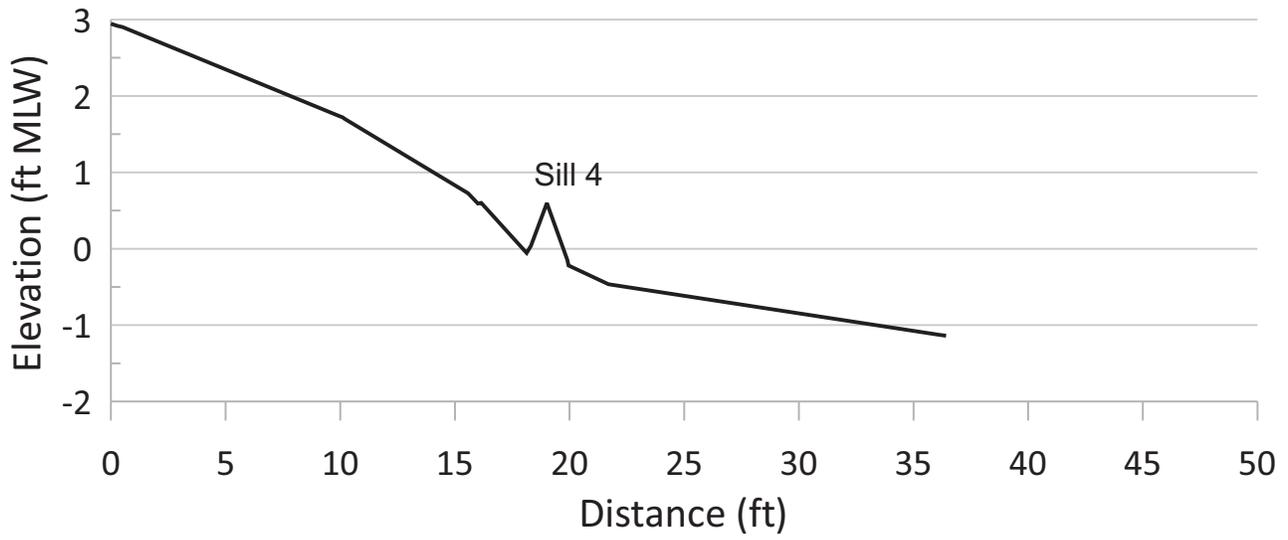
Cross-sectional survey 424 at Sill 4. Survey taken 26 Jan 2018, ten months after installation.

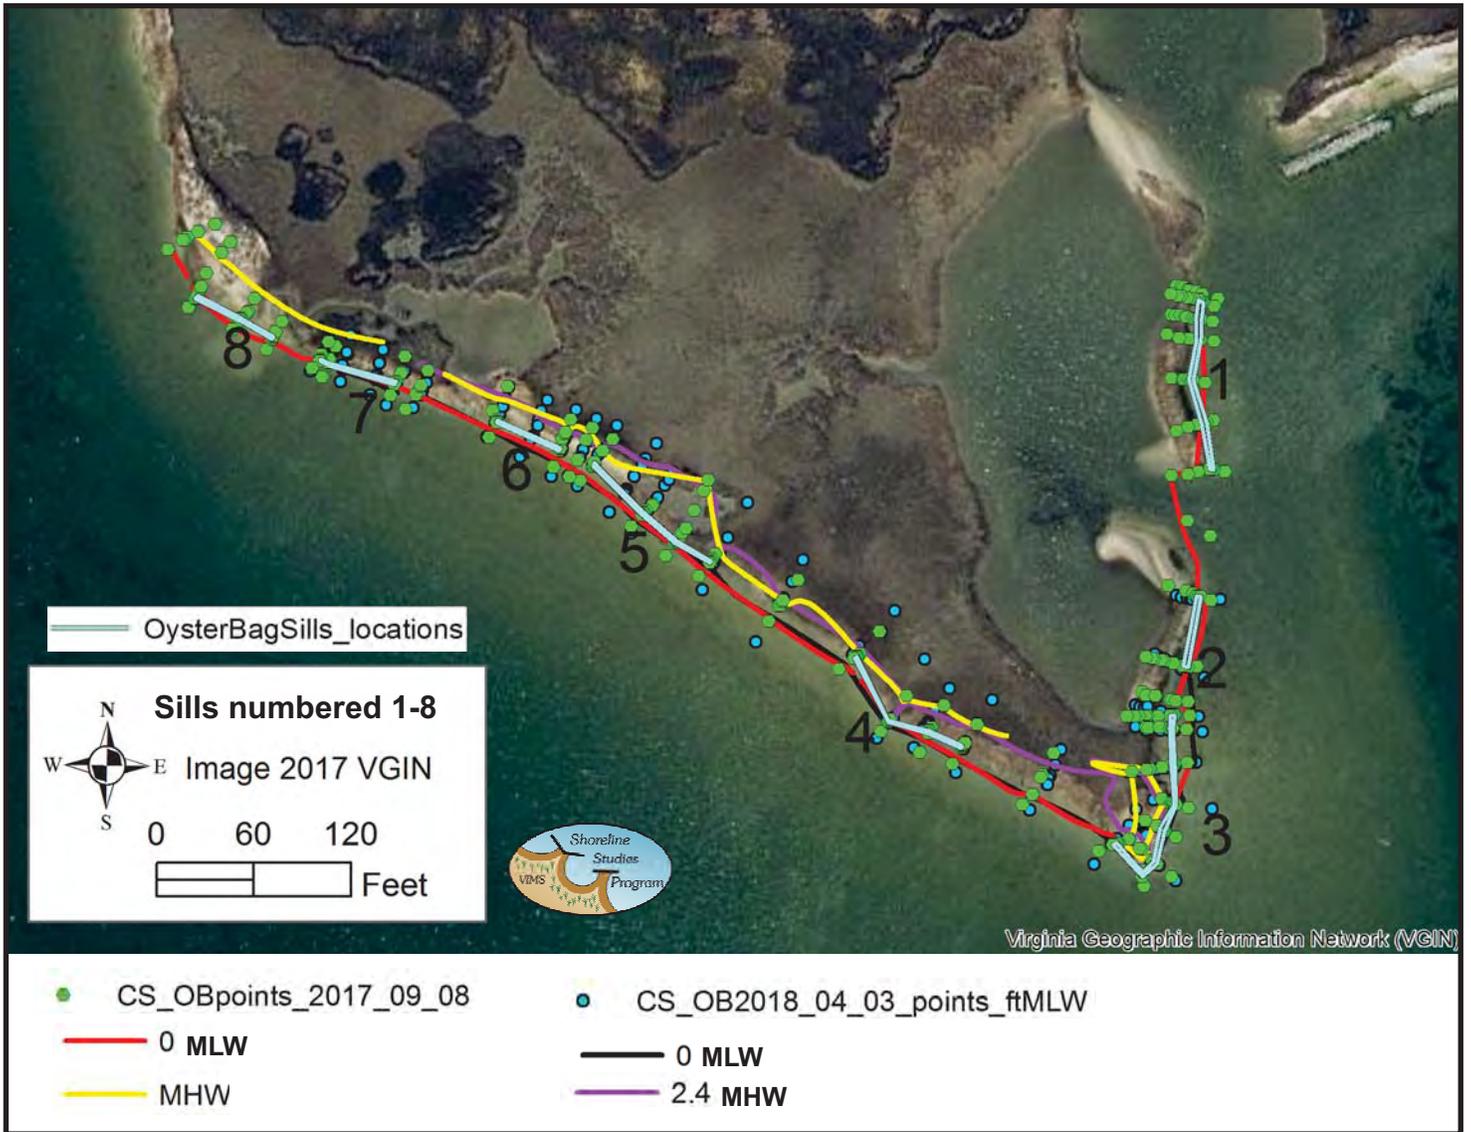
Little change occurred between the post-sill survey in September 2017 and April 2018. Mean low water and mean high water

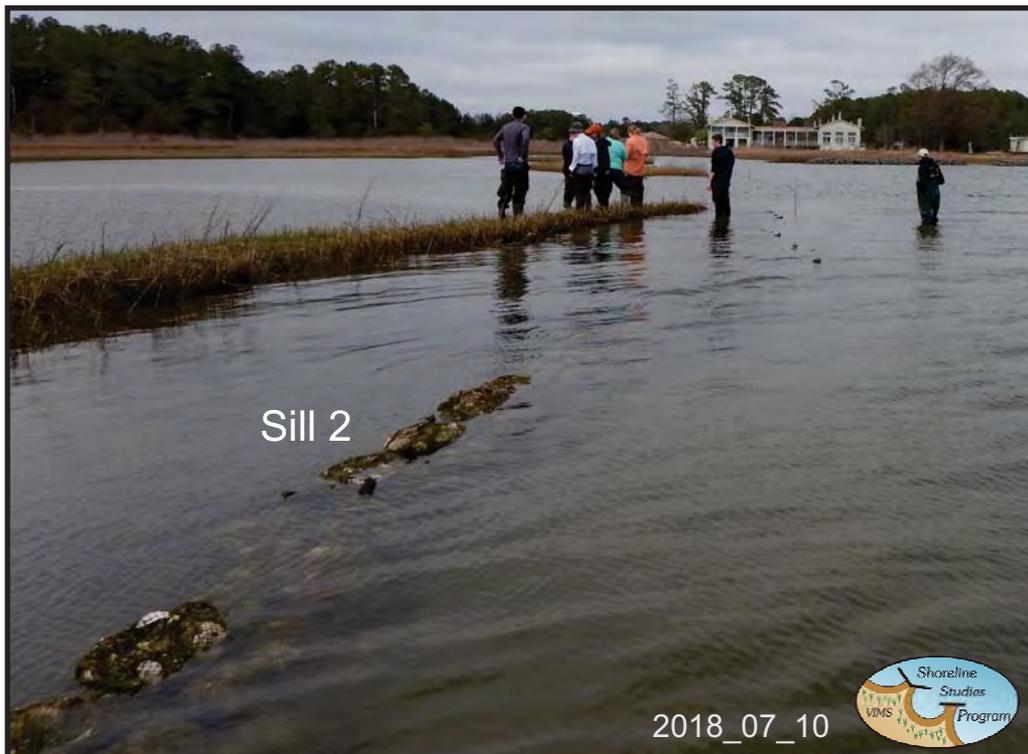
Sills 1 and 2 are 6 bag sills on the east-facing shoreline that fronts narrow, low marsh barriers that are covered at high water.

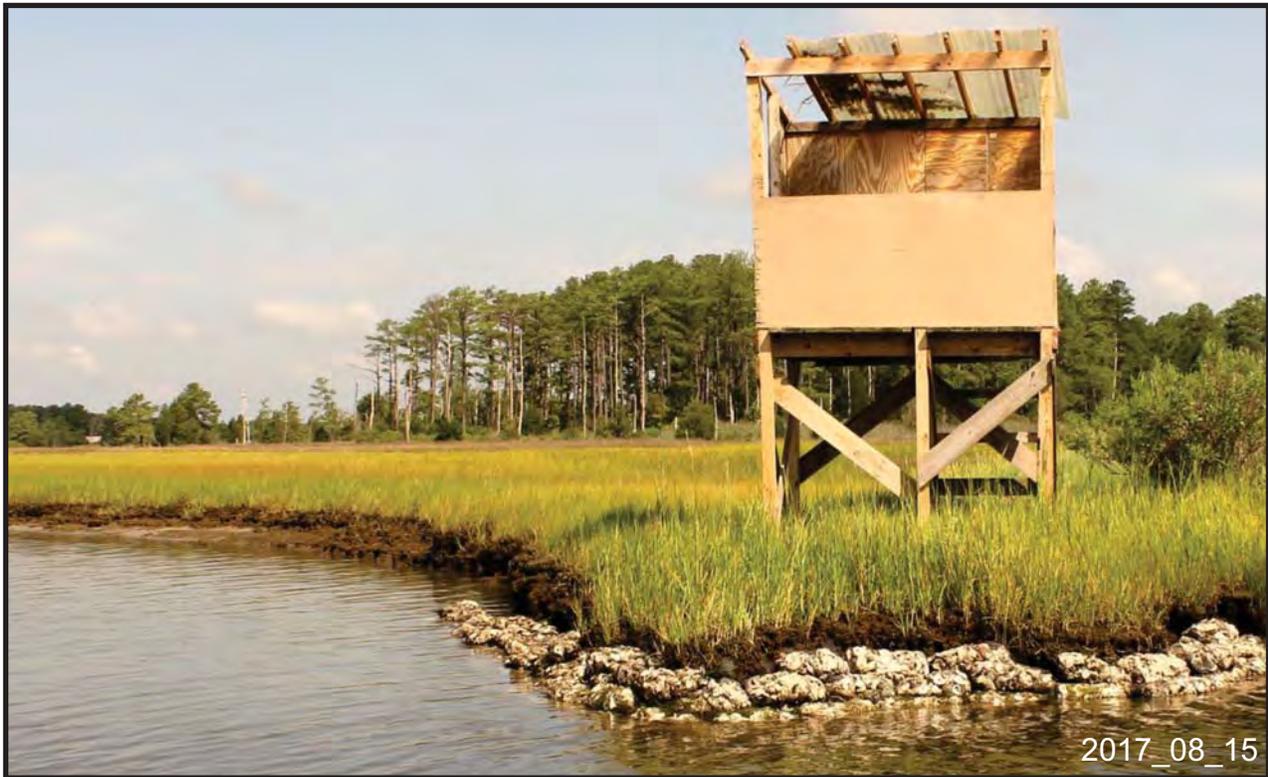
Sill 3 wraps around the point and comes in close to the marsh scarp to provide the maximum amount of protection to the shoreline. Photo credit Linda Tjossem.
